Annual Monitoring Review and Management Report 2022-2023

MMG Rosebery

Date: 30/09/2023

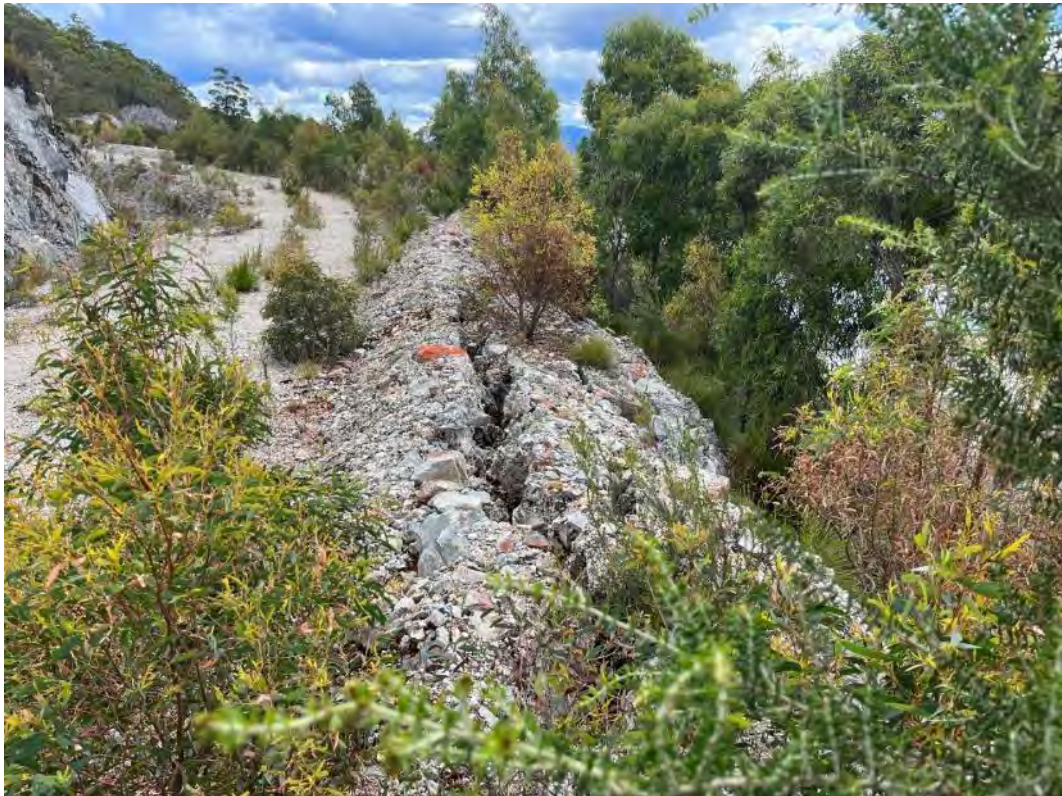
Photograph 3 – Condition of cracking in safety bund on downstream edge of CWDD.

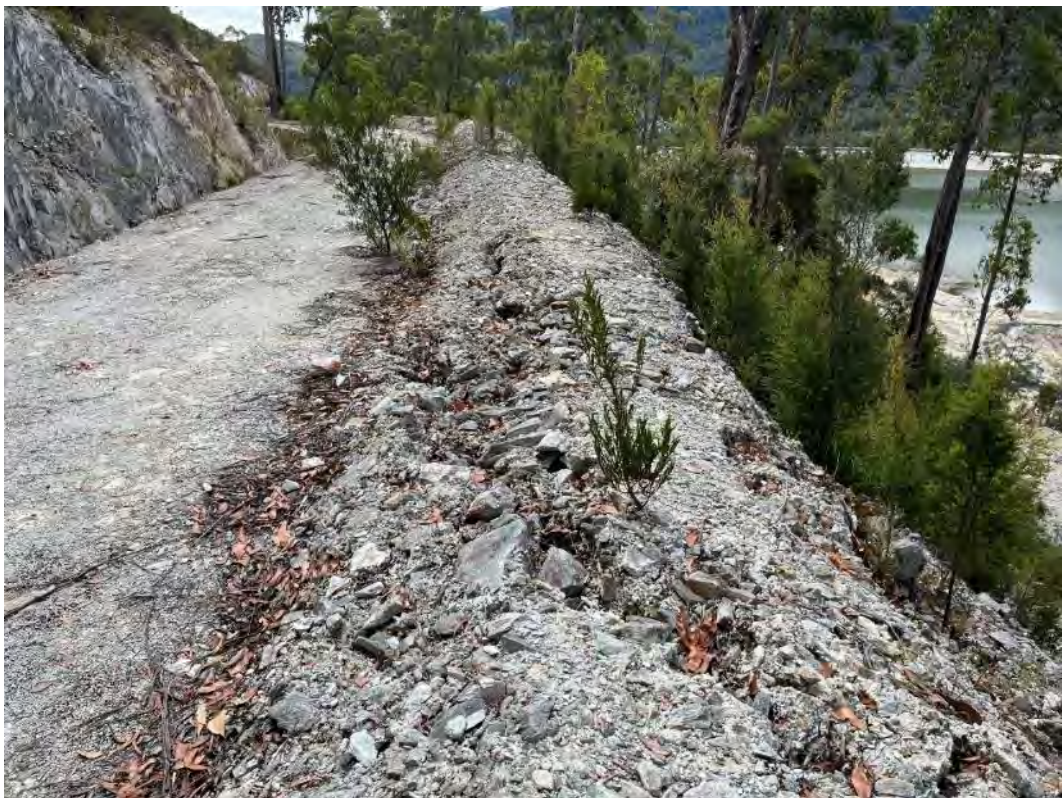
Photograph 4 – Condition of cracking in safety bund on downstream edge of CWDD.

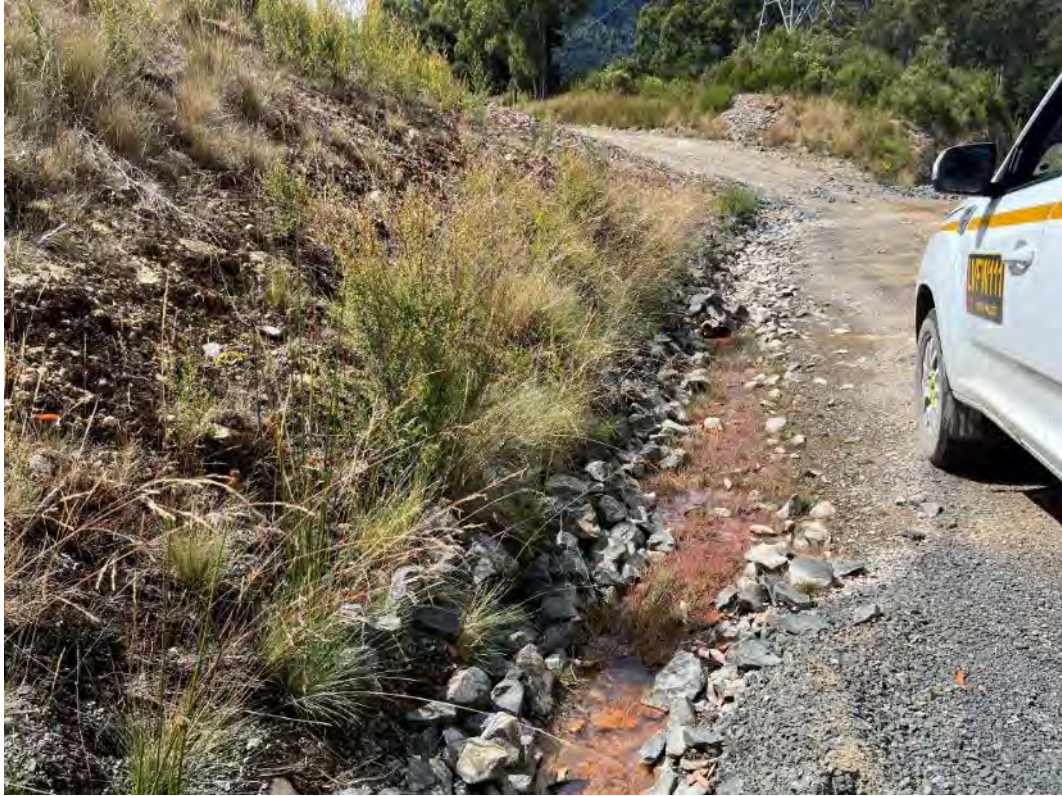
Photograph 5 – Concentrated clear seepage within old chimney drain outlet.

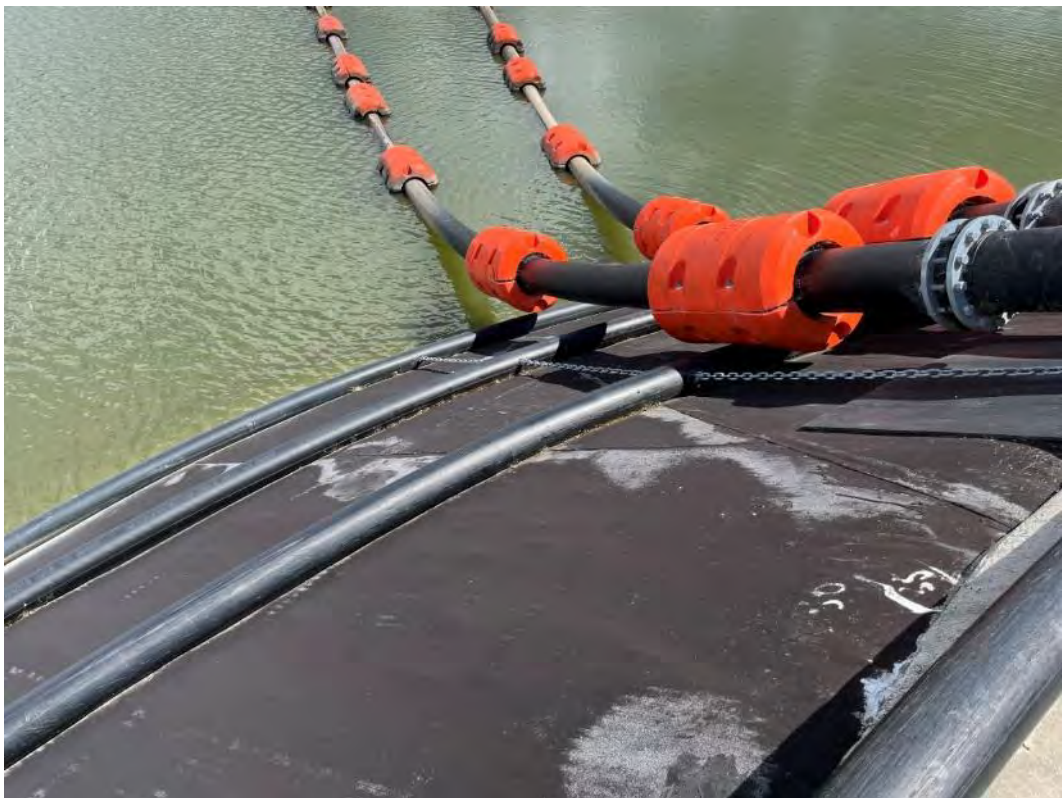
Photograph 8 – damage to Stage 1 liner on upstream face of eastern embankment due to dragging of pipeline.

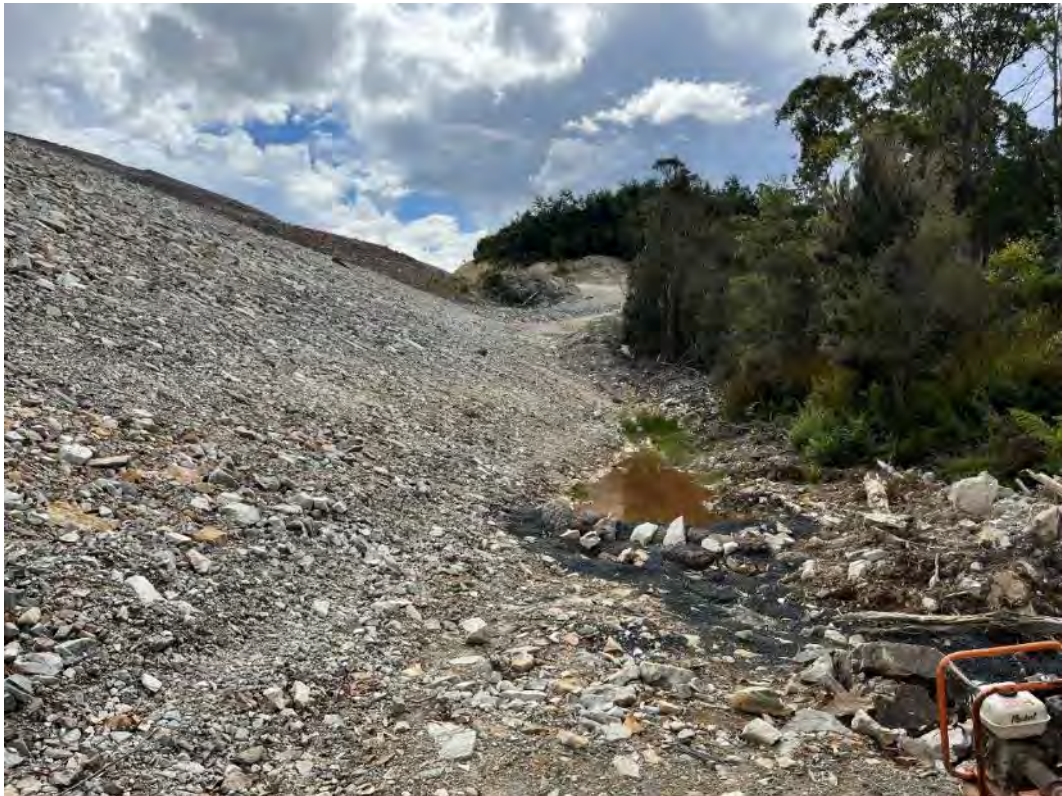
Photograph 9 – seepage at the western end of northern embankment.

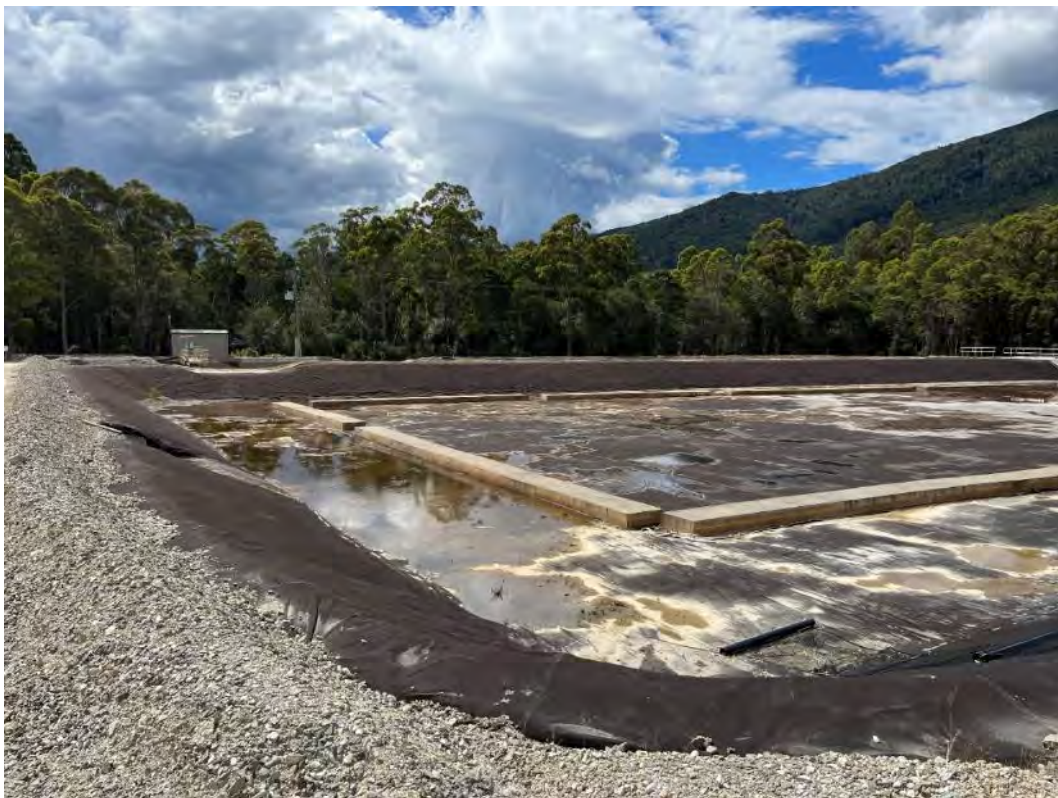
Photograph 18 – seepage return pipeline previously located on SCP liner has caused damage to the lining system and will require repair.

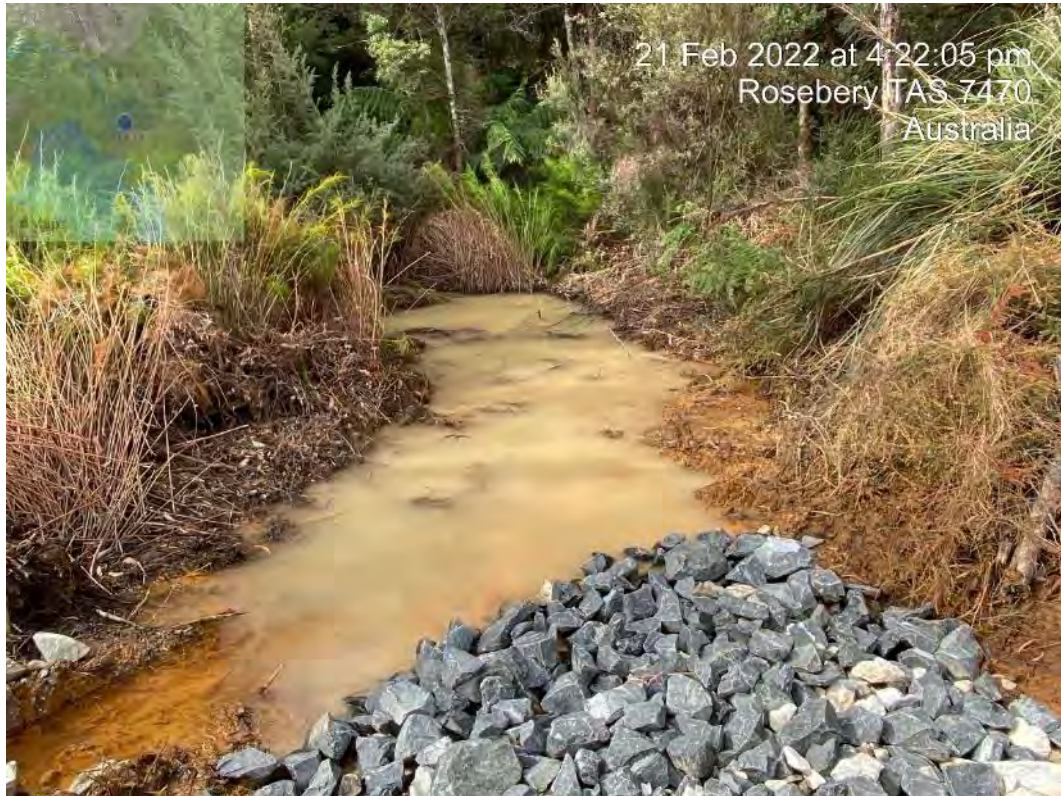
Photograph 19 – sediment laden seepage water (legacy seepage) downstream of the Stage 2 northern embankment buttress.

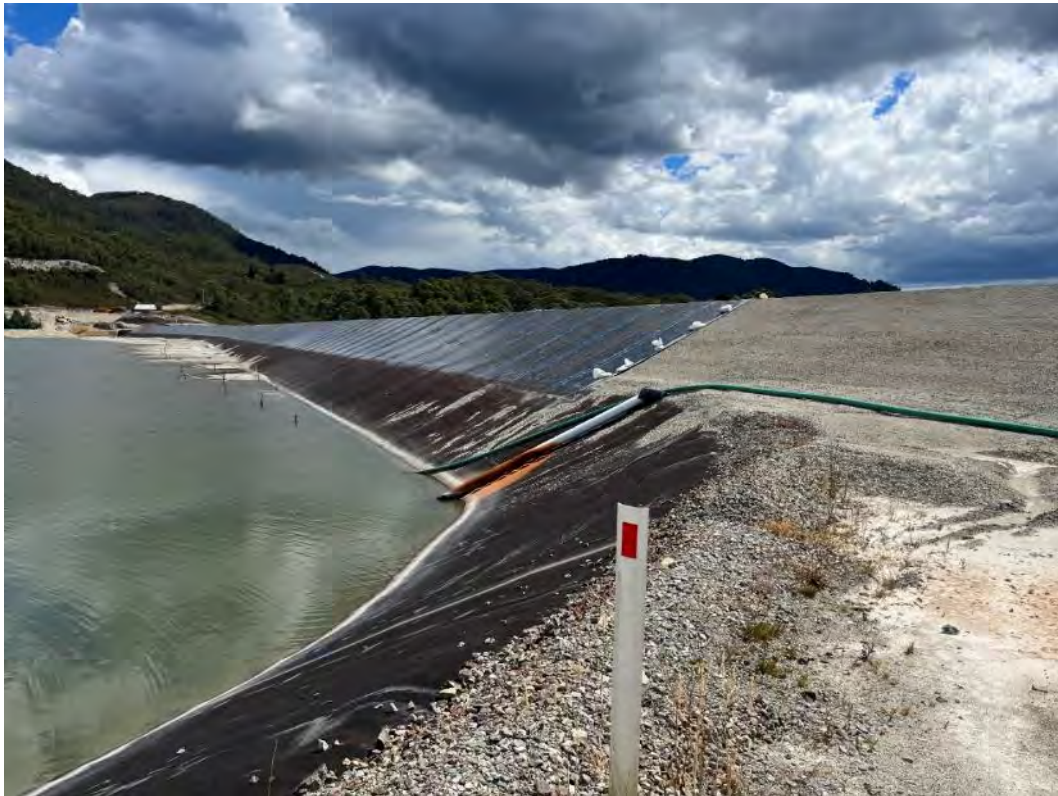
Photograph 23 – upstream face of western embankment, looking south. Stage 2 raise recently completed.

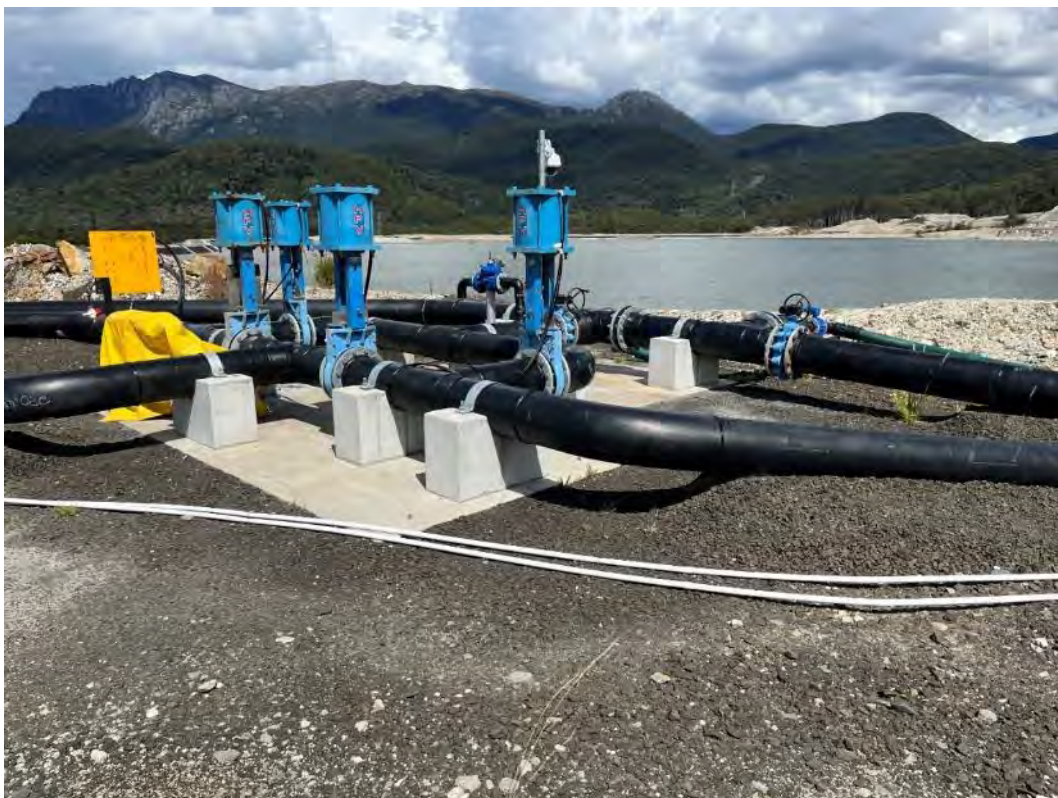
Photograph 28 – Footing at valve station has been repaired since previous inspection.

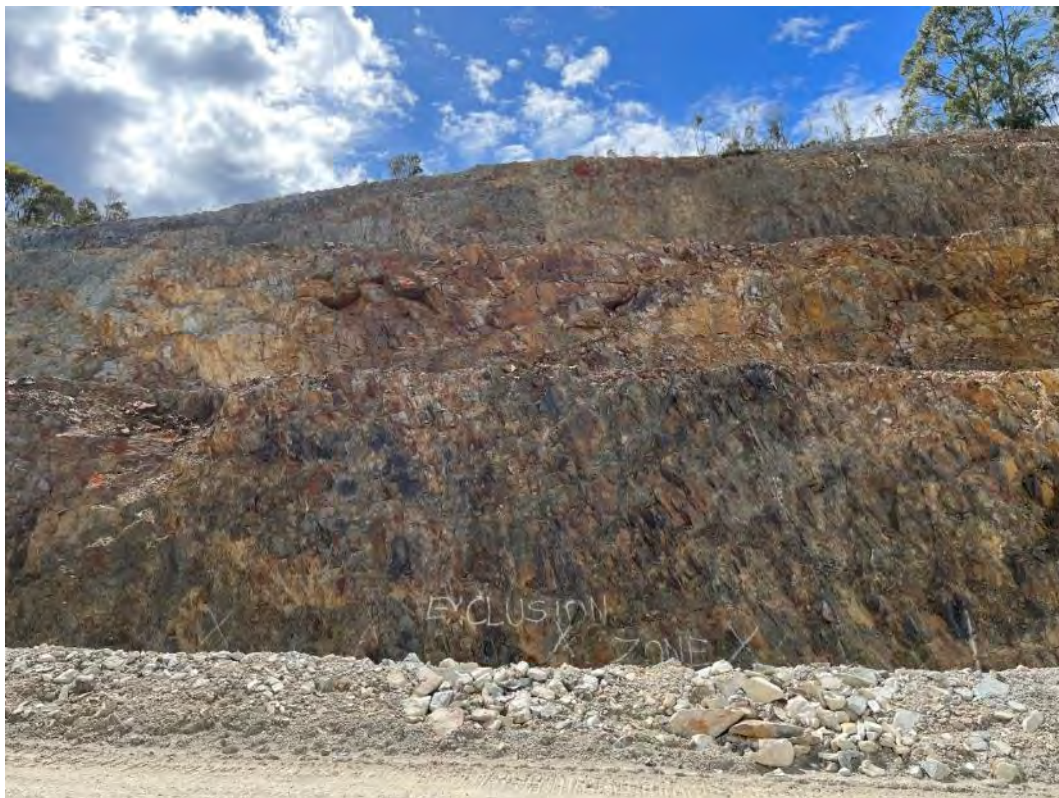
Photograph 32 – loose rock in western cut face of the diversion channel

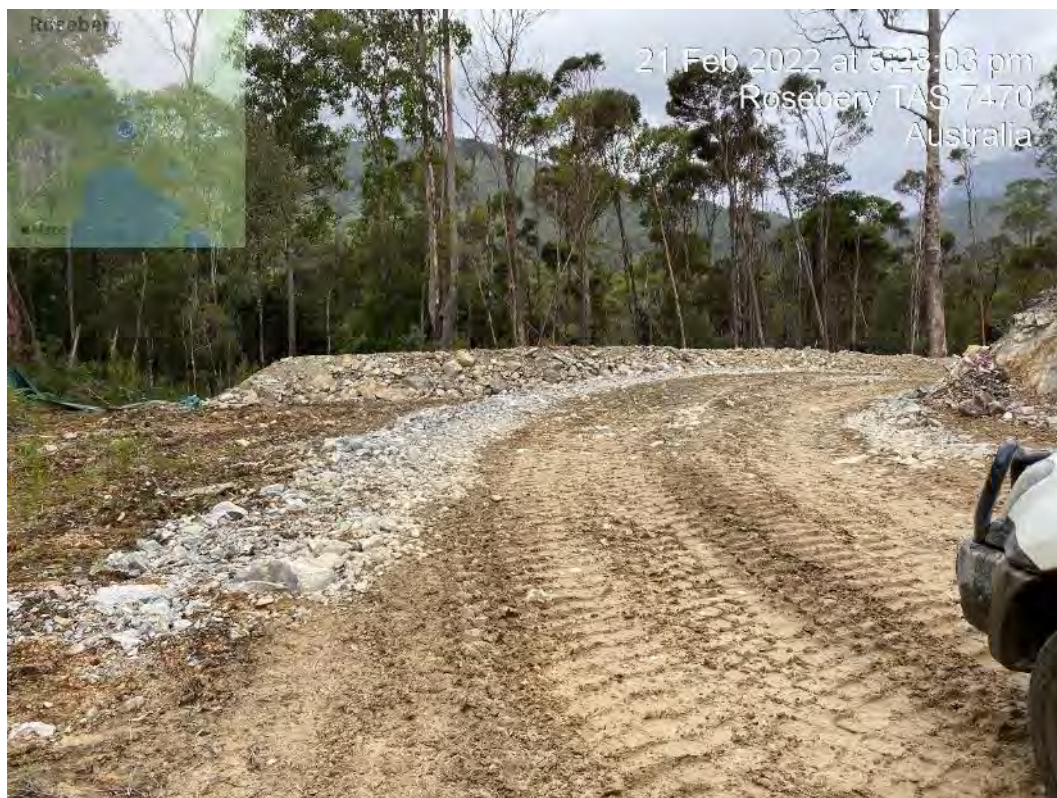
Photograph 33 – bund formed across the outlet to the diversion channel (to be removed once stage 2 works are complete).

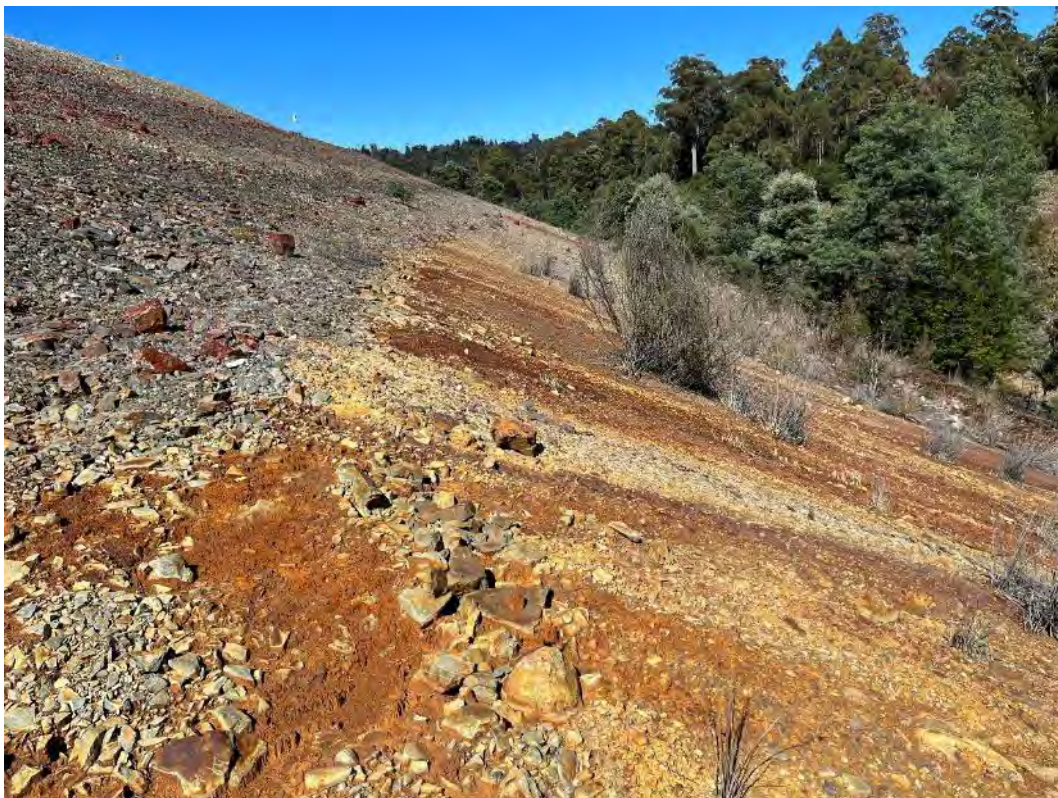
Photograph 14 – Iron staining on downstream slope of the Levee embankment, looking south. The iron staining is originating between the Stage 5/6 raises.

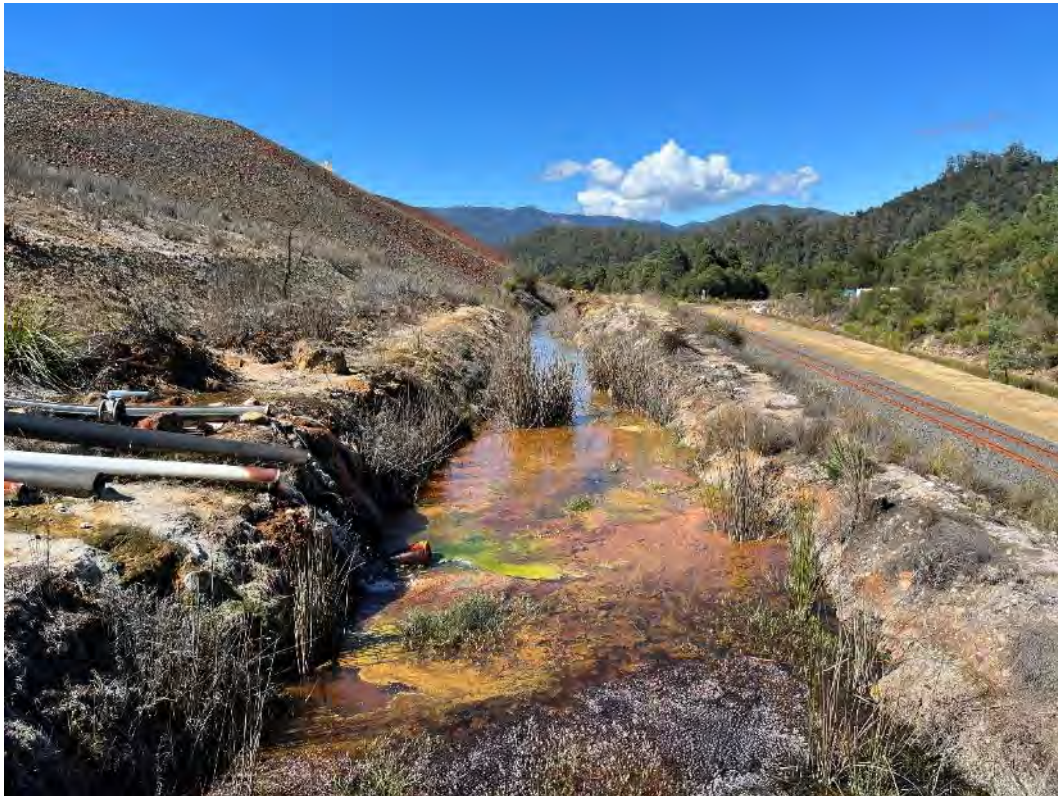
Photograph 15 – condition of the old decant drain, looking south from headwall.

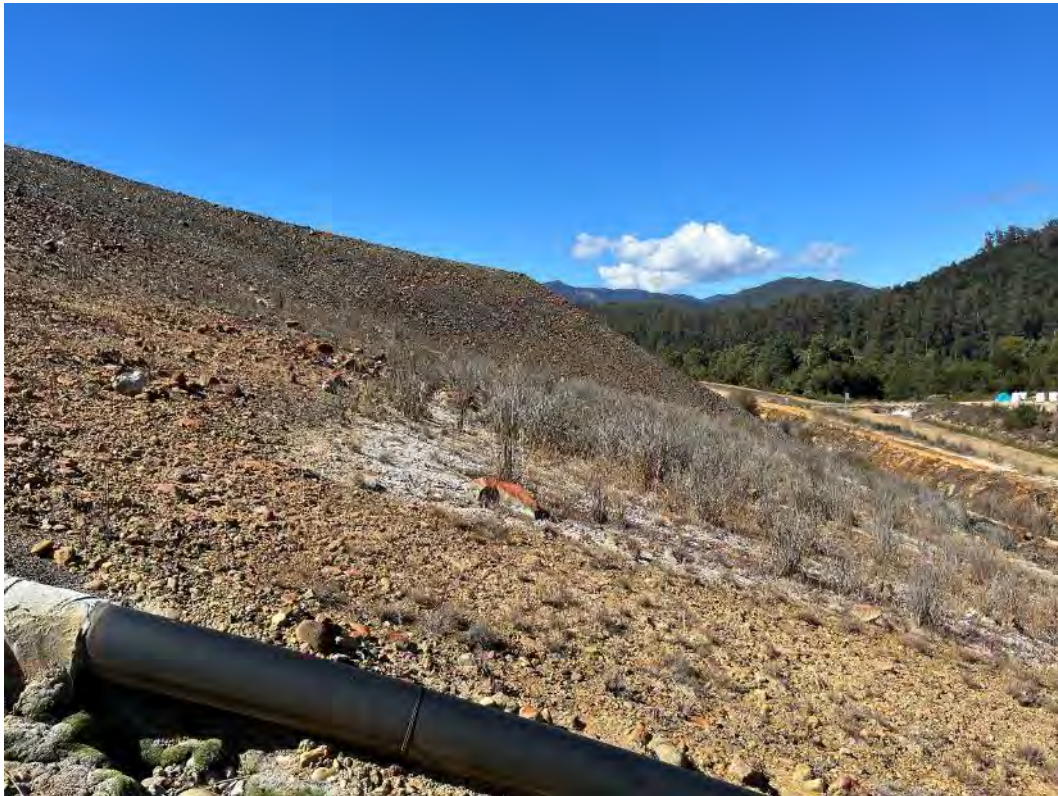
Photograph 29 – reeds on downstream batter of Levee embankment signify the upper extent of broad wet area.

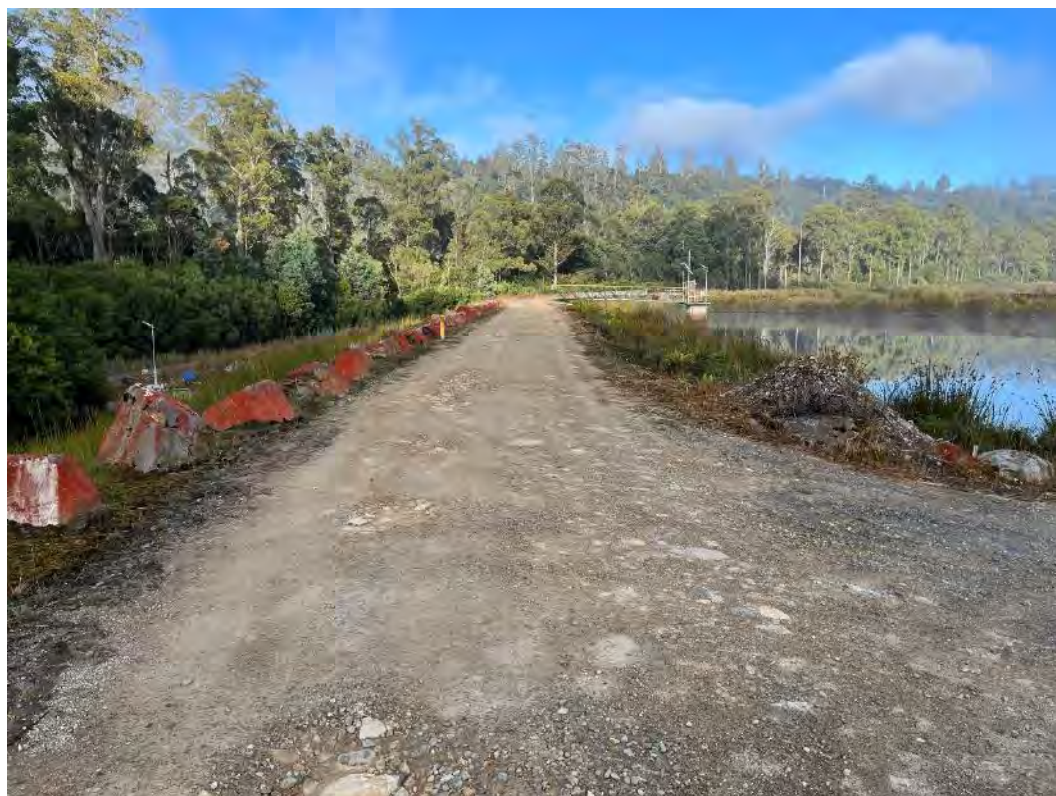
Photograph 36 – Polishing Pond – typical condition of the crest

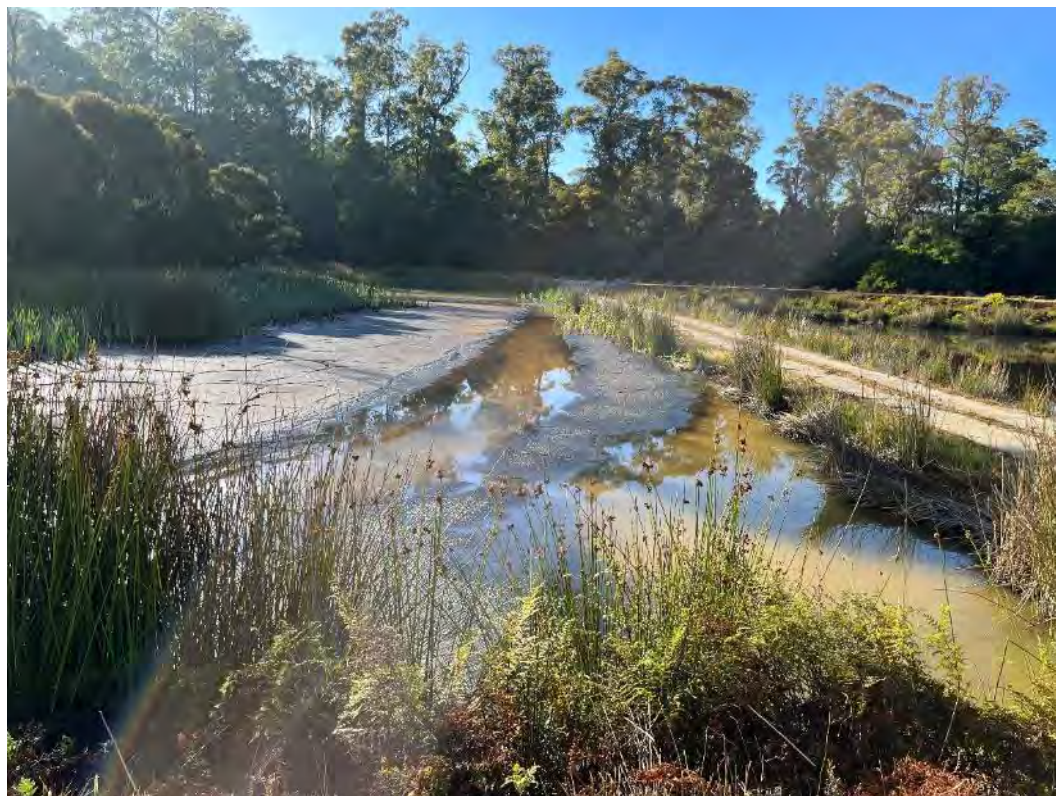
Photograph 39 – Polishing Pond Cell 1. Large amounts of sludge have accumulated within several cells.

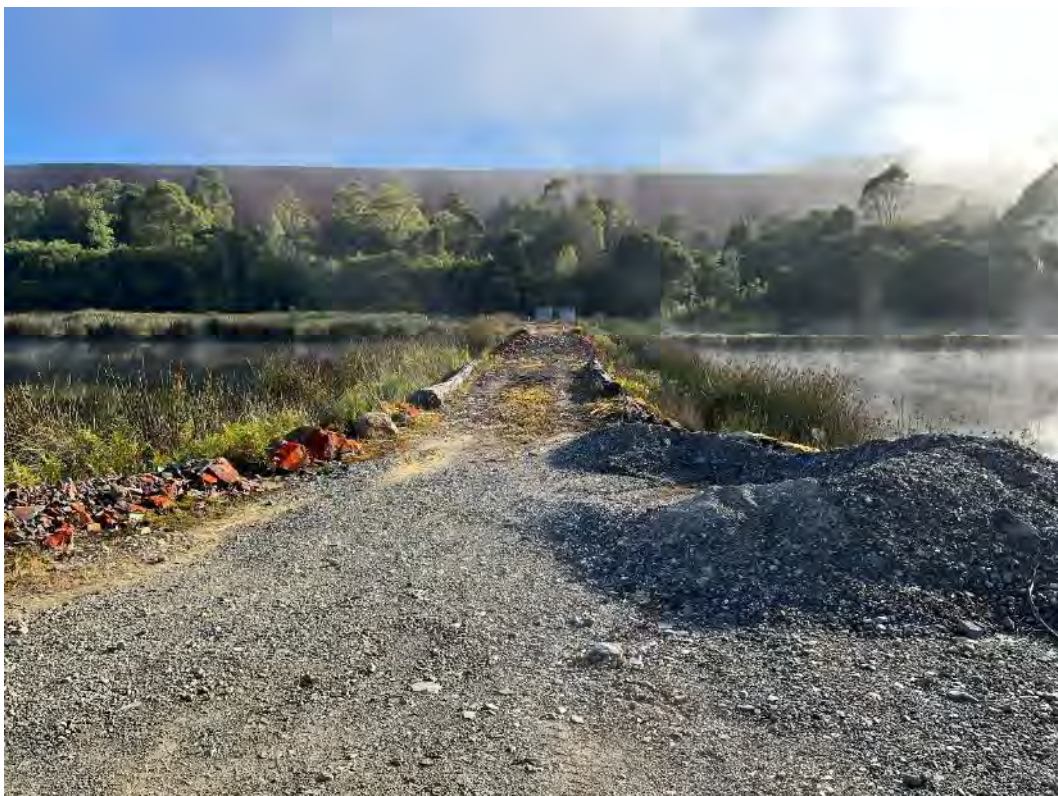
Photograph 44 – Polishing Pond – overgrown cell 3/4 dividing embankment slashed. Vegetation at internal spillway (background) should also be removed.

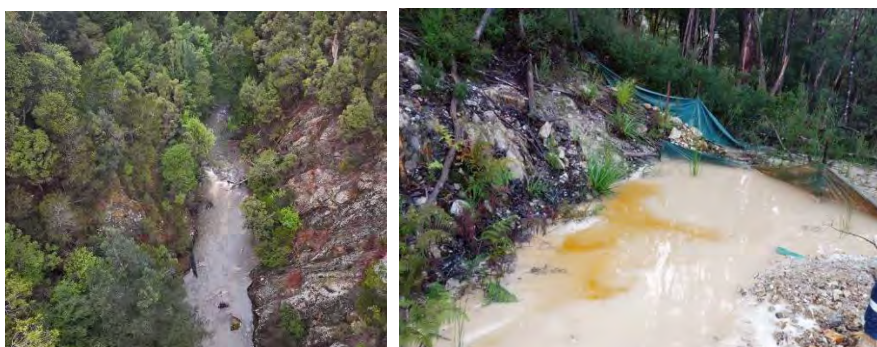
On 7 July 2022, MMG Rosebery notified the EPA via email regarding the discharge of turbid water from the emergency spillway and northern wall of the 2/5 Dam TSF embankment into the Stitt River. The event was caused by 37 mm of rain falling in the previous two days mobilising sediment from construction areas around the 2/5 Dam TSF (Figure 2-1). The company reported that the runoff was observed late in the afternoon with additional controls to reduce sediment runoff implemented the next morning. Management measures included the construction of additional silt fences and 'eco logs', and the positioning of pumps that can be used to transfer turbid water back to the TSF if required (Figure 2-2). The company also implemented a sediment control review at the site and conducted an audit of contractors HSE policies.

Figure 2-1. Photos of the Stitt River during the turbidity event and short-term immediate measures to reduce sediment discharge to the river.
