# PROGRESSIVE REHABILITATION AND CLOSURE PLAN

## DUGALD RIVER MINE

MINERALS AND METALS GROUP PTY LTD

**JULY 2023**

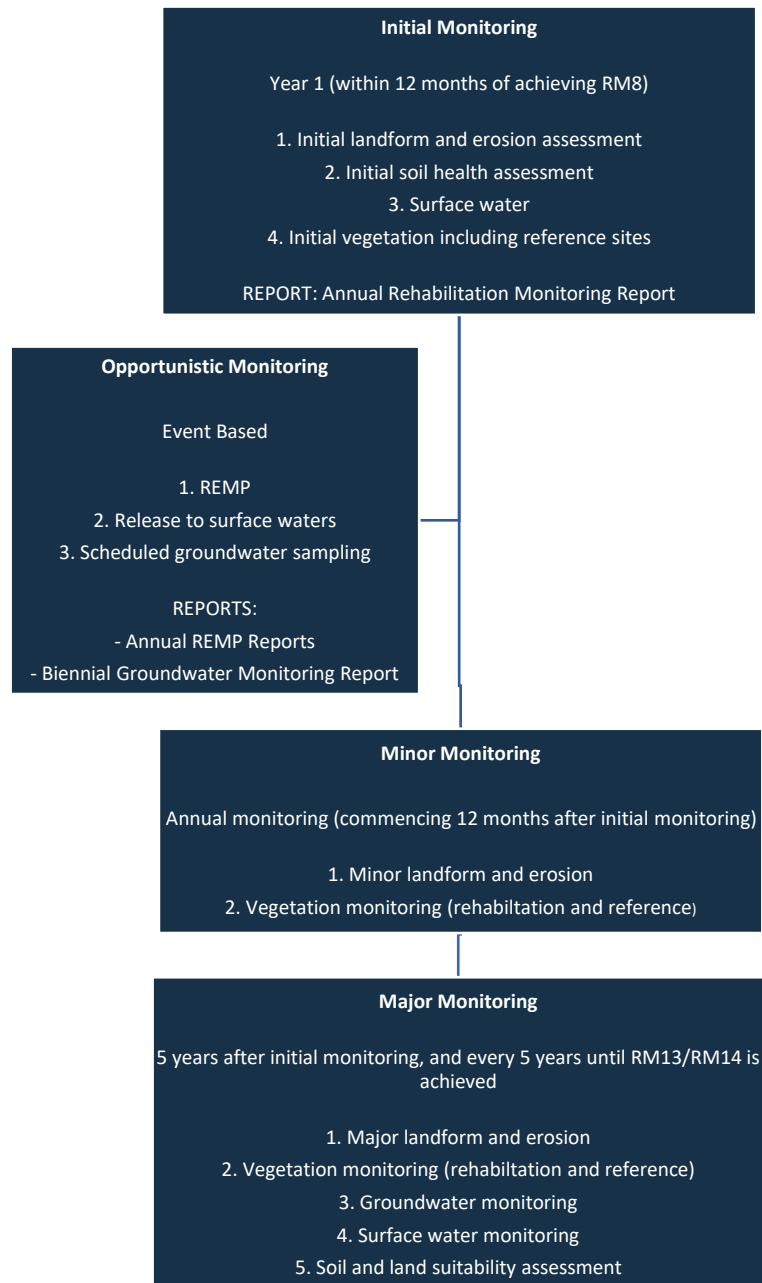
Figure 15 Rehabilitation Monitoring Phases

The Rehabilitation Monitoring Program (Section 3.7.1) has been designed to demonstrate that RM13 and RM14 have been achieved. There are three main phases to the Project's rehabilitation monitoring program as displayed in Figure 15.

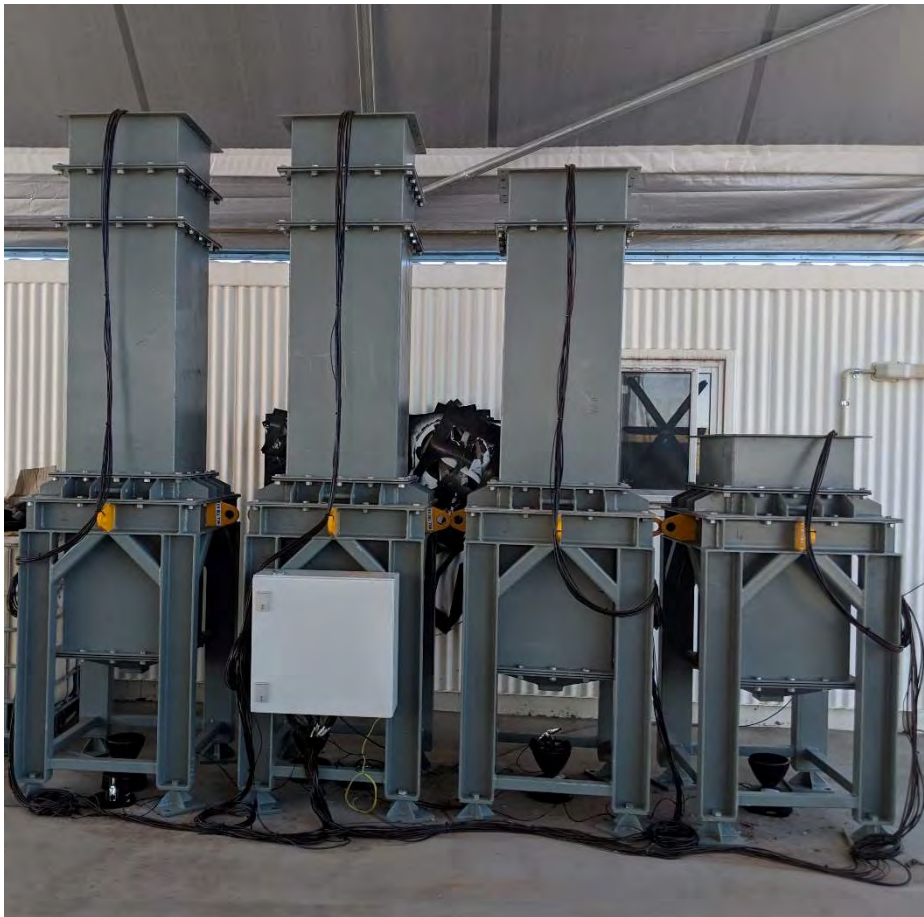
**Photograph 1 Cover column trial**

Four columns, one for each cover option, were built to specifications provided by SGME. A built column is shown in Photograph 1. Columns ranged from 1.1 m to 2.5 m tall depending on the thickness of the cover trialled. Each column has a surface area of 0.25 metres squared (m<sup>2</sup>).

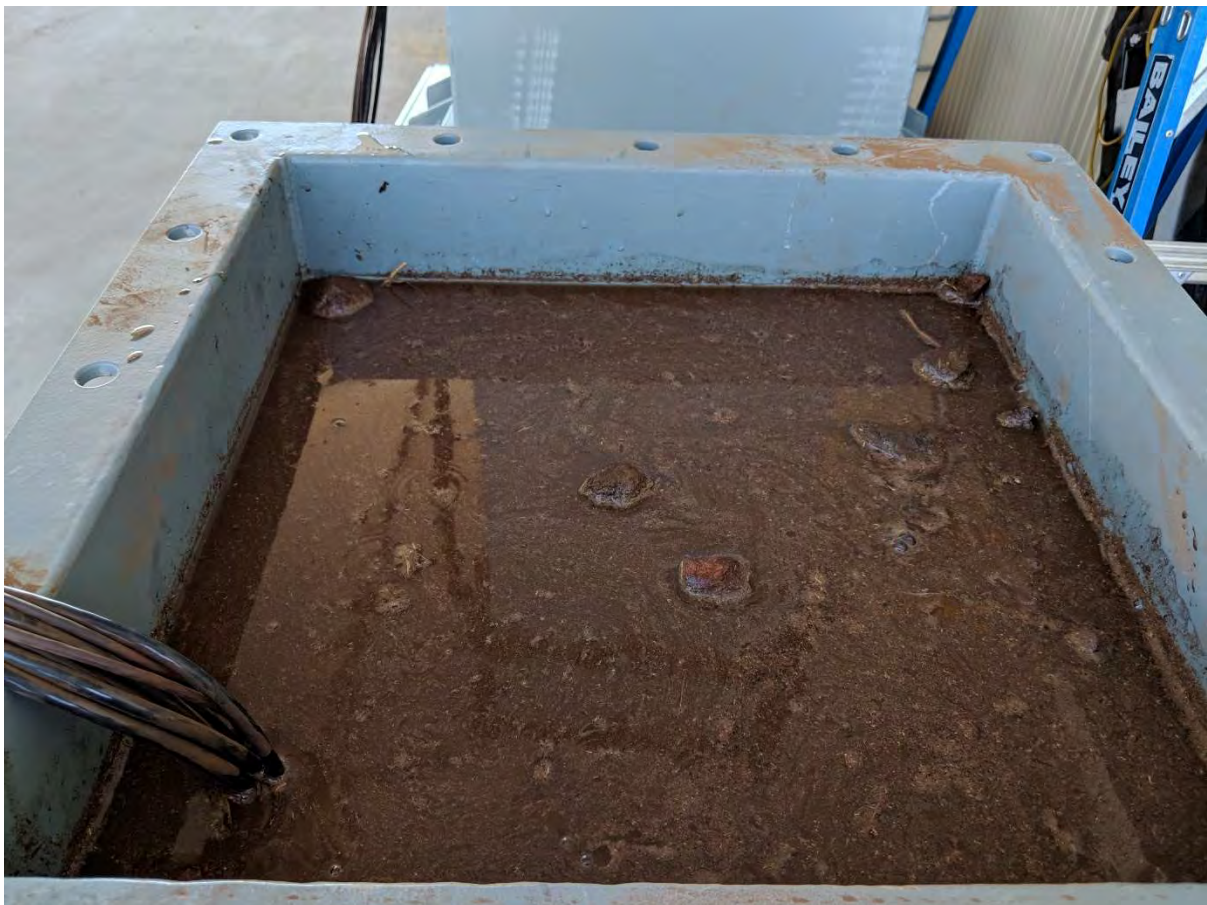
**Photograph 2 Ponding of water on the trials**

During wetting events, artificial rainfall could pond on the surface of the trials (Photograph 2).

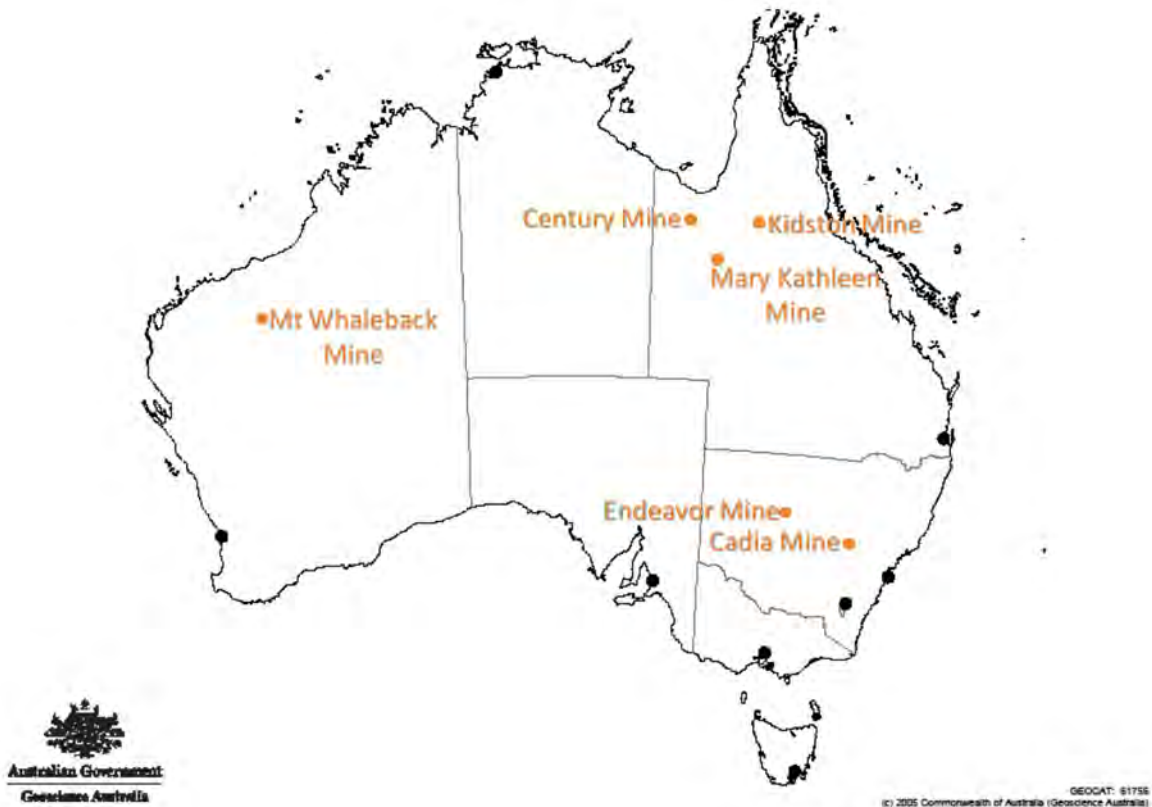
**Figure 14 Location of mines with cover trials**

- Mt Whaleback Mine and Peak Gold Mine exemplify mono layer covers since the cover is an ISL only (Ayres et al. 2003, O’Kane et al. 2000, O’Kane & Walters 2003) (Figure 14).
- Kidston Mine, Cadia Mine, Century Mine, Endeavor Mine and Mary Kathleen Mine exemplify duplex covers as the covers utilise a RPL overlain by an ISL (Williams et al. 1997; Durham 2002; Wilson 2000, Rohde & Williams 2009, Rohde, Defferrard & Lord 2016; Rohde et al. 2017 & Lottermoser 2003) (Figure 14).

The ratio of evaporation to rainfall (evaporation:rainfall) exceeds two at all of the mines, meaning that store and release covers are appropriate for each mine (Figure 14 and Table 26).

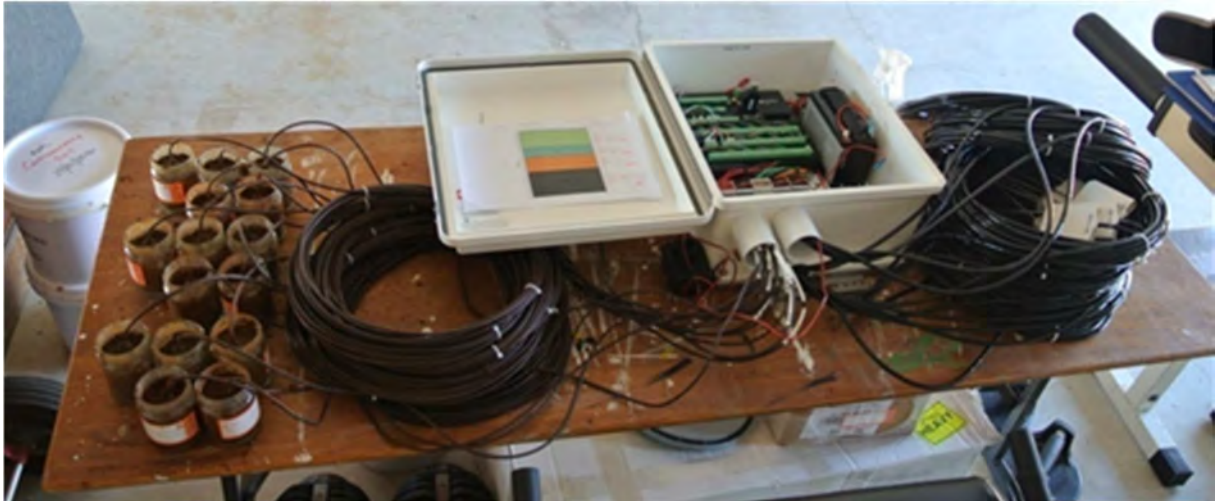
Photograph 3 Matrix suction sensor calibration

Photograph 3 illustrates the experiment set up for calibration. Matric suction sensors are embedded at the expected field density and wired to the data logger ready for measuring the  $\Delta T$ .

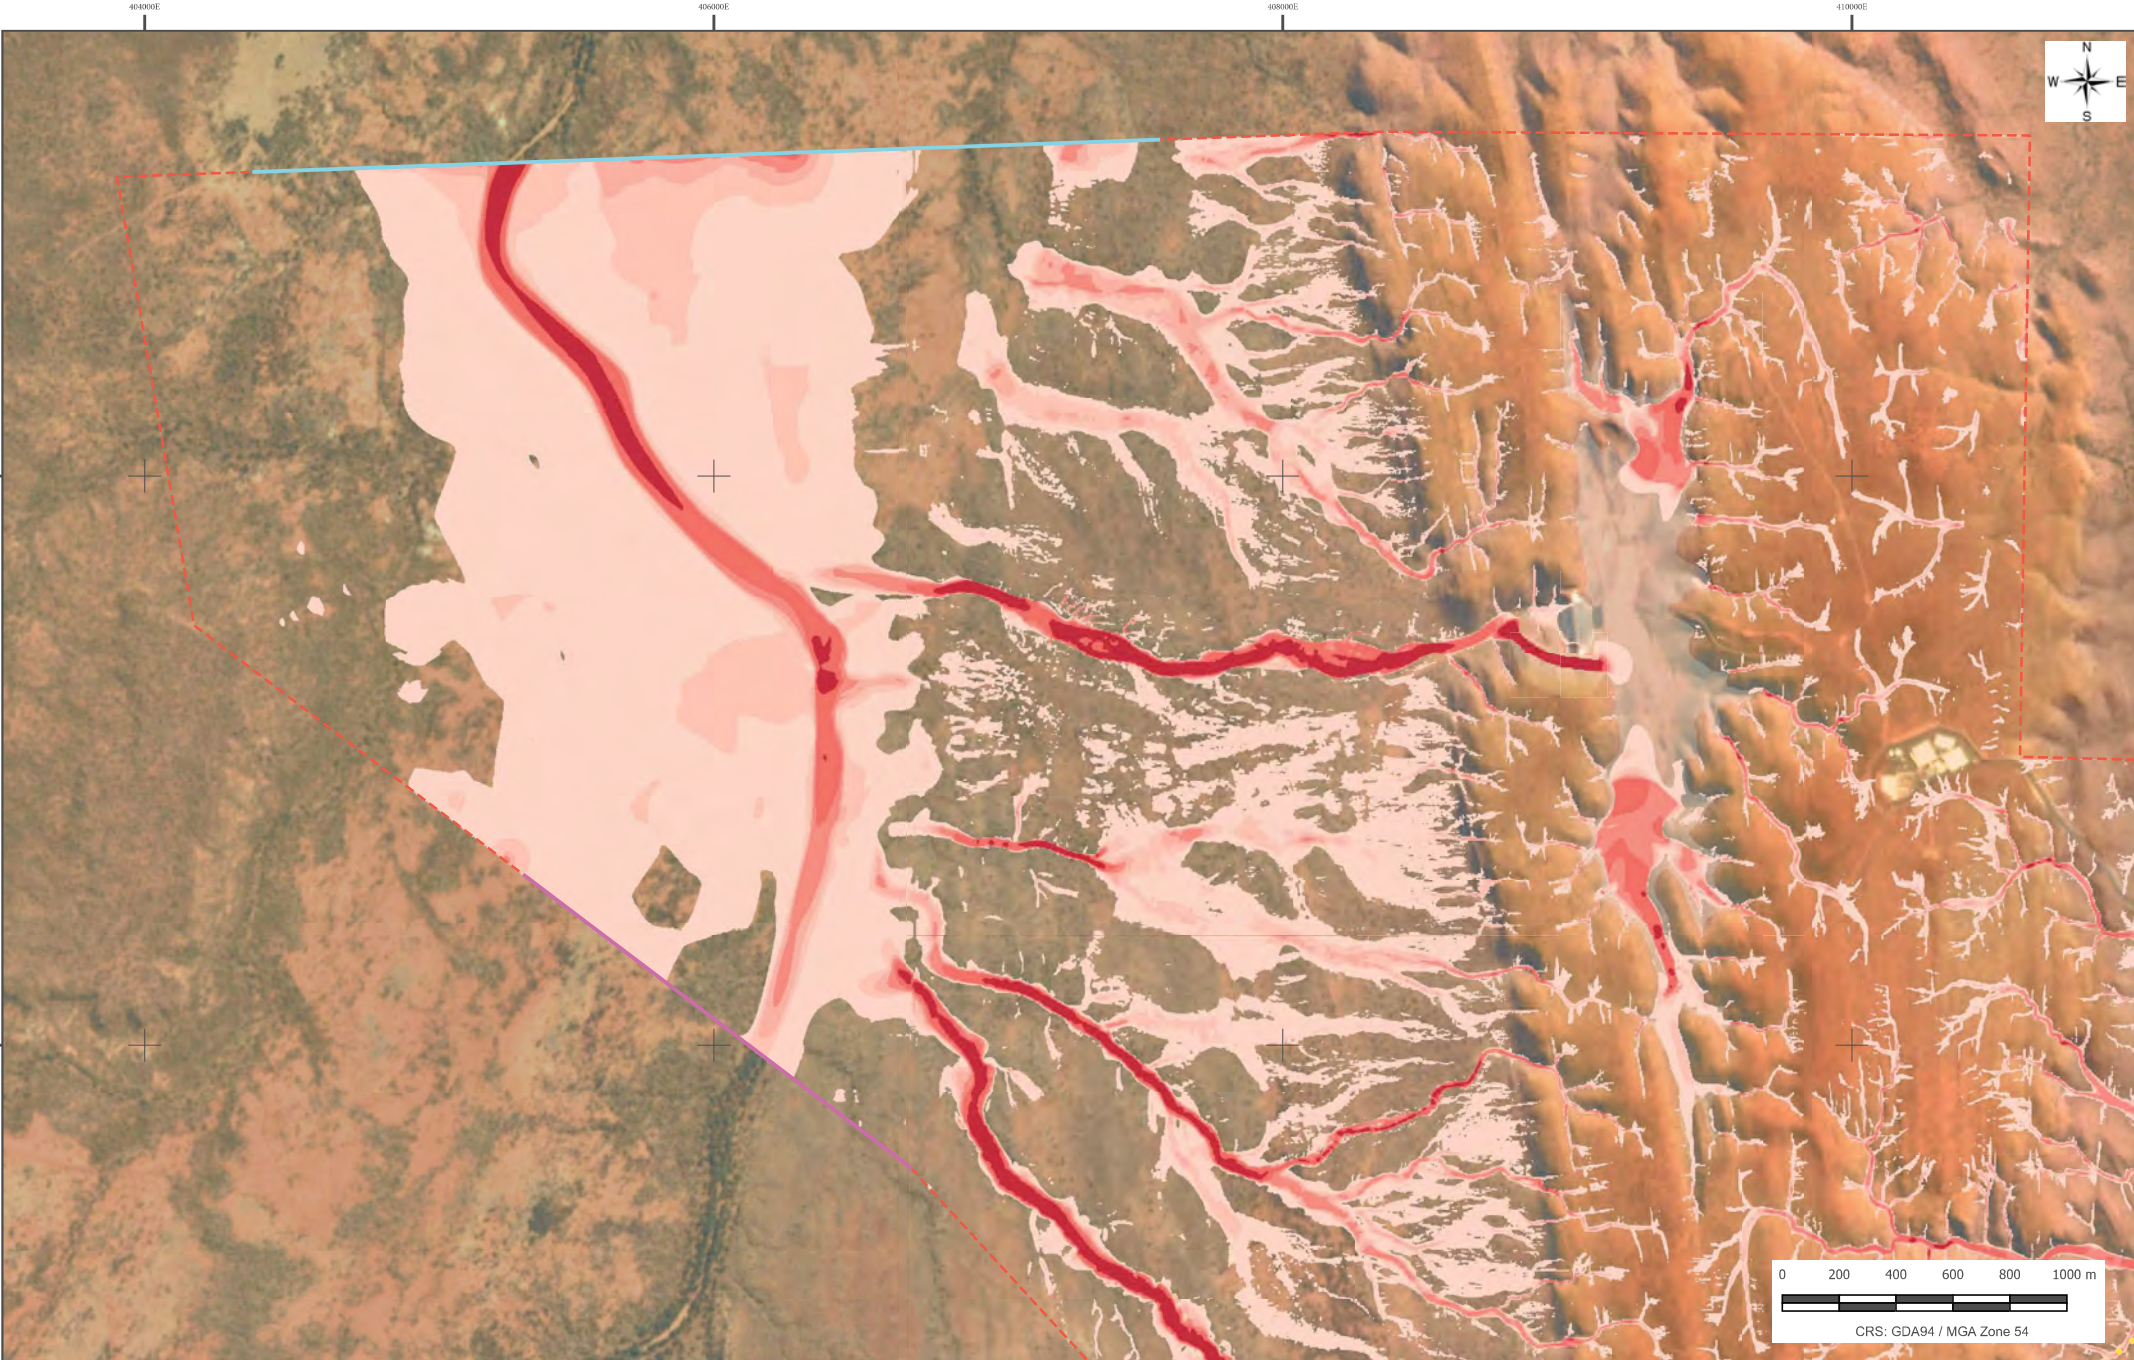
**FIGURE 001**  
 108003-49  
 DATE: 2021-05-18

MMG AUSTRALIA PTY LTD  
 DUGALD RIVER MINE  
 TSF PMP - MAXIMUM FLOOD VELOCITY

The results of the TUFLOW model showing maximum water depths and velocities are presented in **Figure 001** to **Figure 012**.
