Annual Monitoring Review and Management Report 2022-2023

MMG Rosebery

Date: 30/09/2023

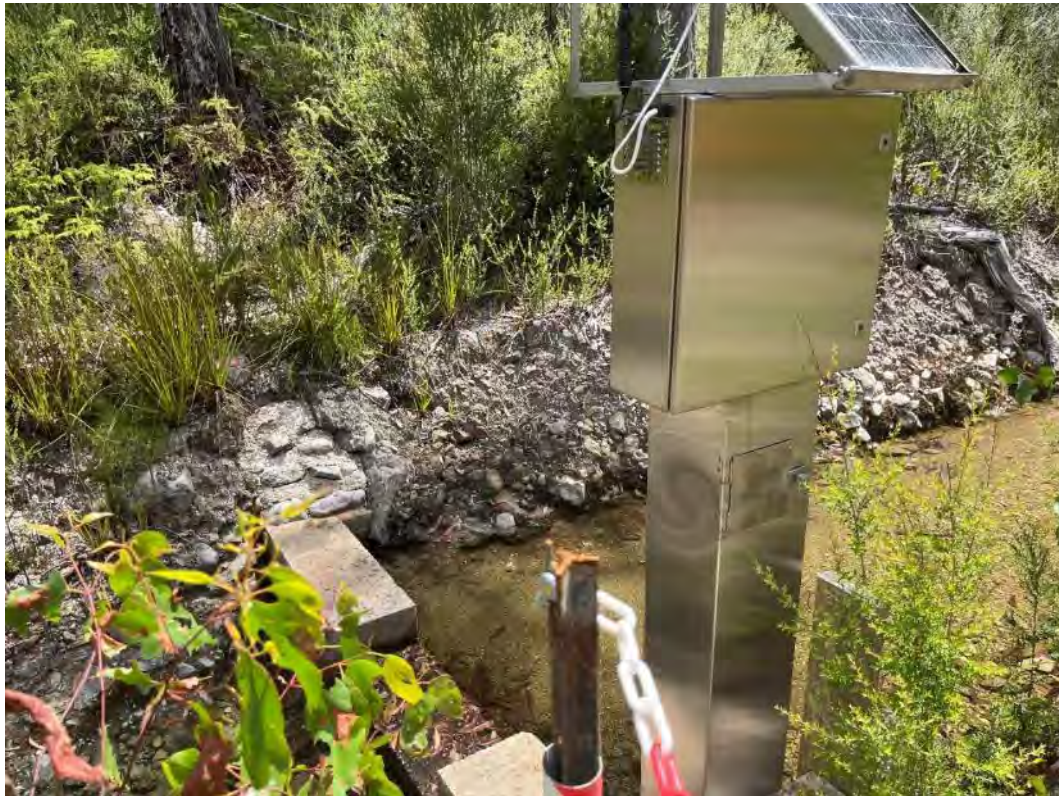
Photograph 1 – Flow measuring weir installed at eastern end of CWDD

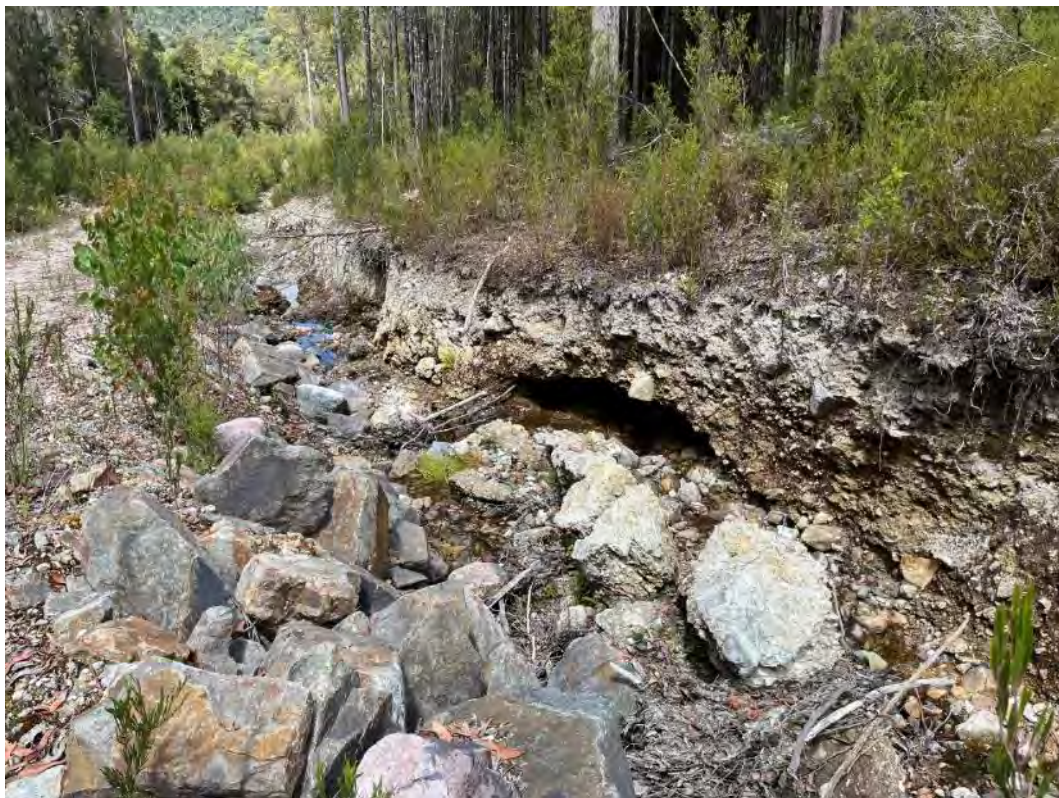
Photograph 2 – CWDD eroded upstream side slopes through glacial clays/silts. Does not interfere with water flow and does not affect access road profile. Has continued to slightly increase in extent compared to 2021 inspection.

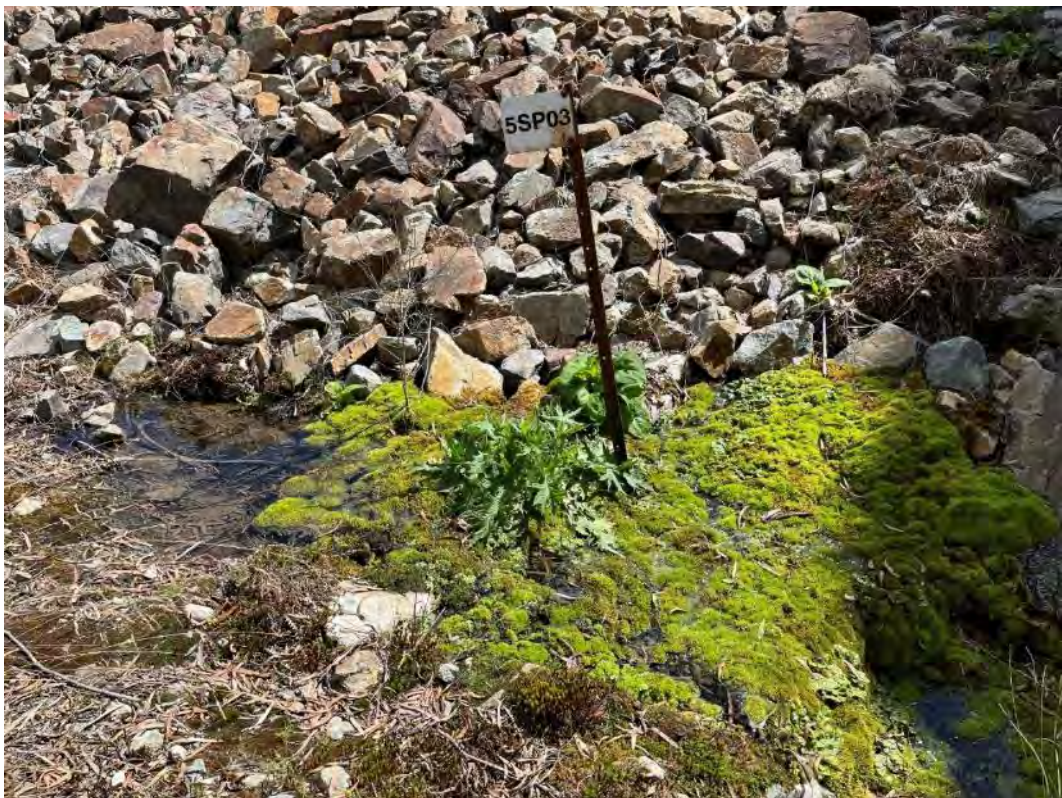
Photograph 10 – Toe seepage from original 5 Dam chimney drain outlet.

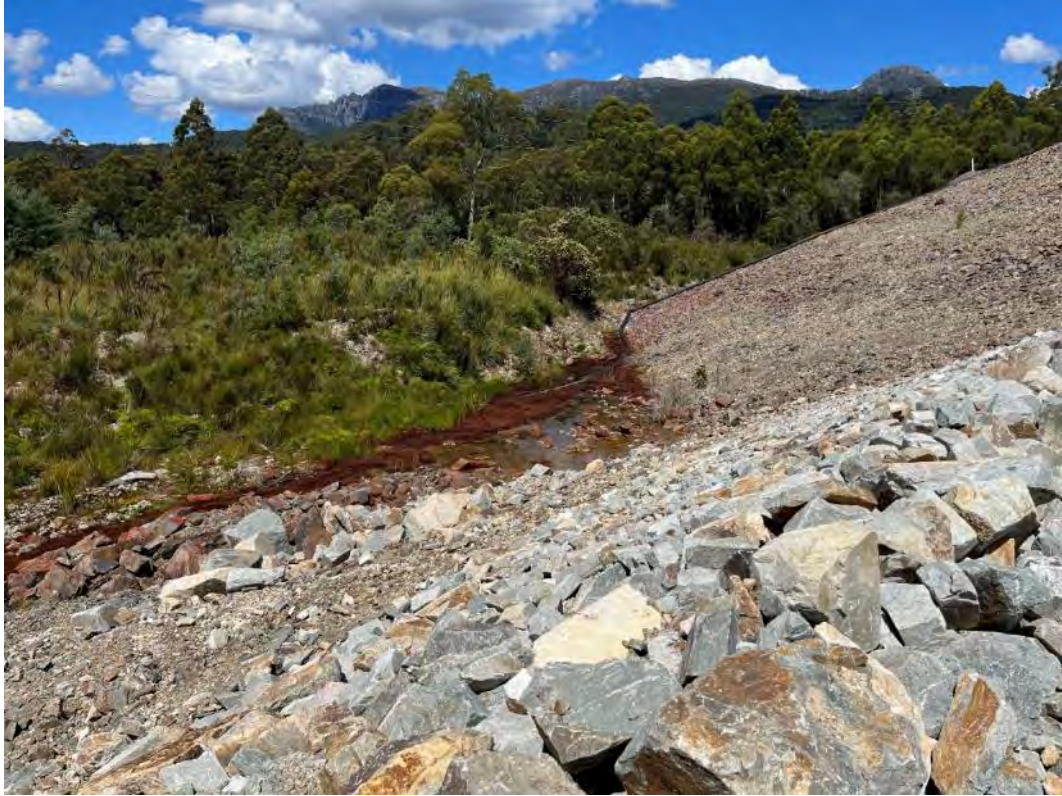
Photograph 11 – pooled seepage from original 5 Dam chimney drain outlet.

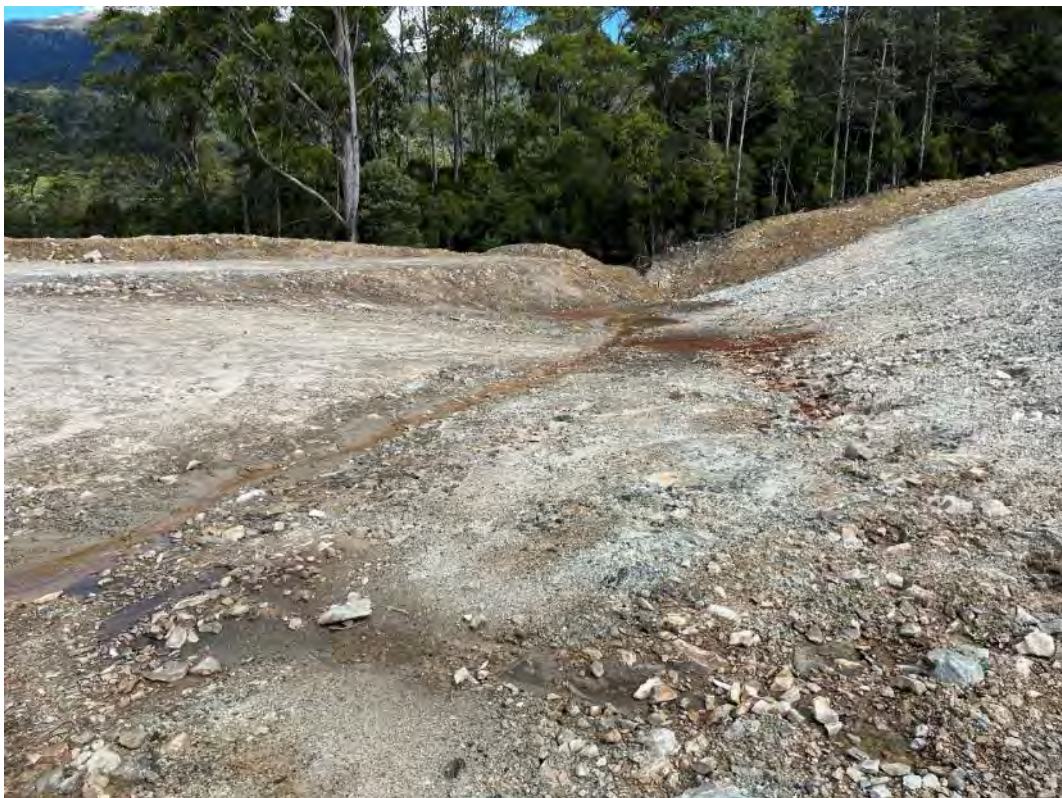
Photograph 12 – toe seepage from toe of original 5 Dam / 2 Dam interface.

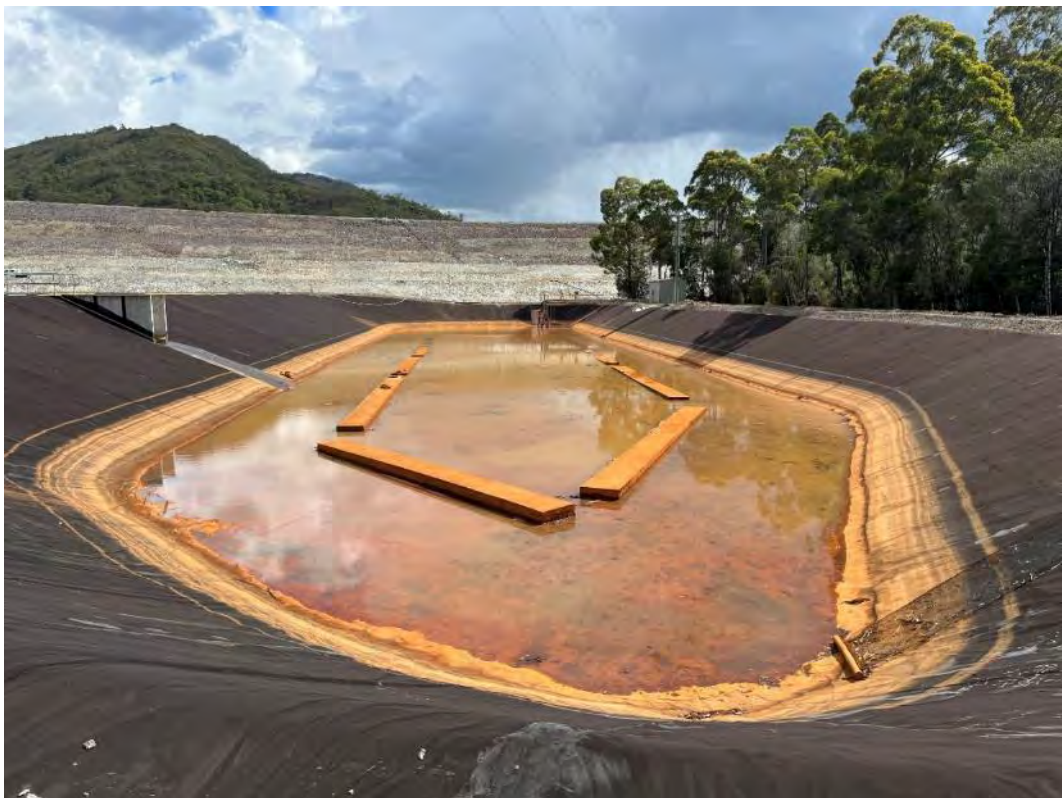
Photograph 16 – overview of lower SCP, looking south from north.

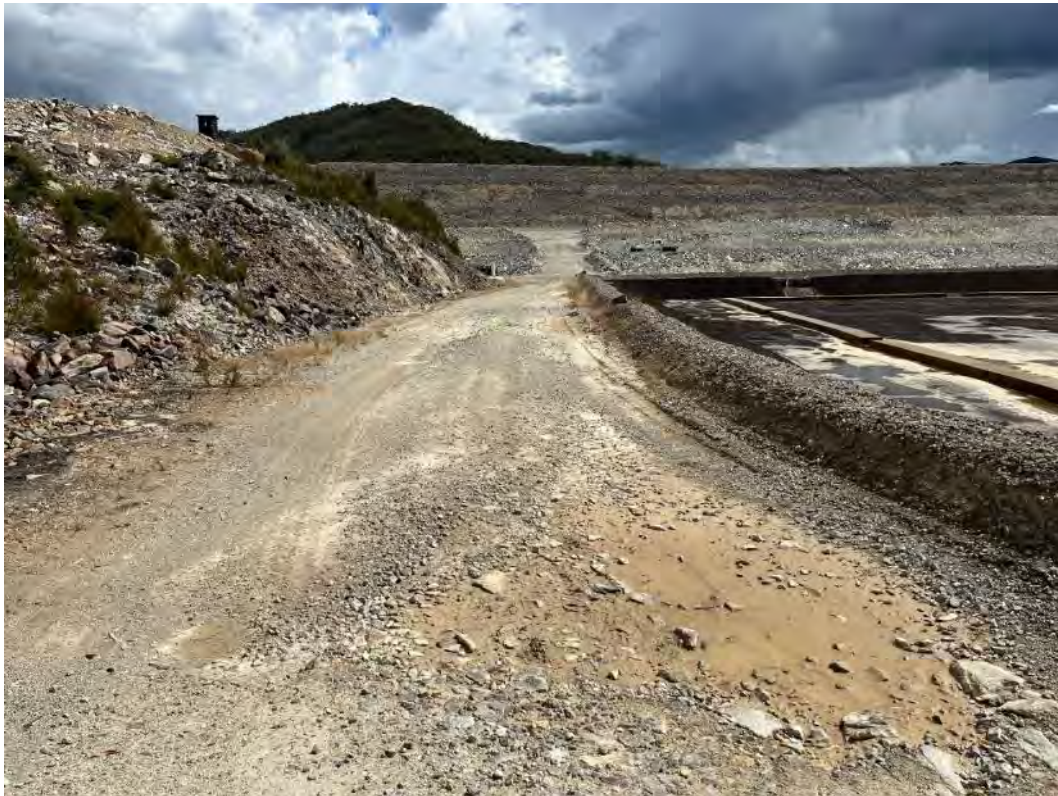
Photograph 17 - Low points on eastern crest of the SCP. Maintenance required.

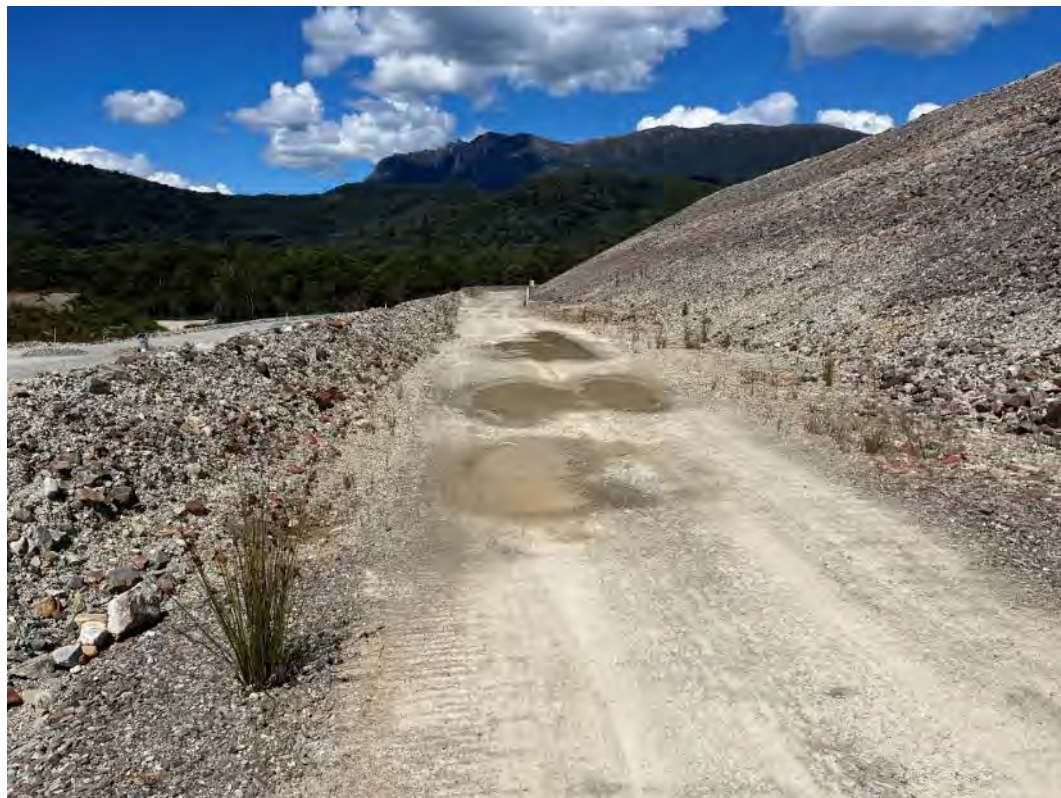
Photograph 20 – northern embankment bench, pooling water, looking east.

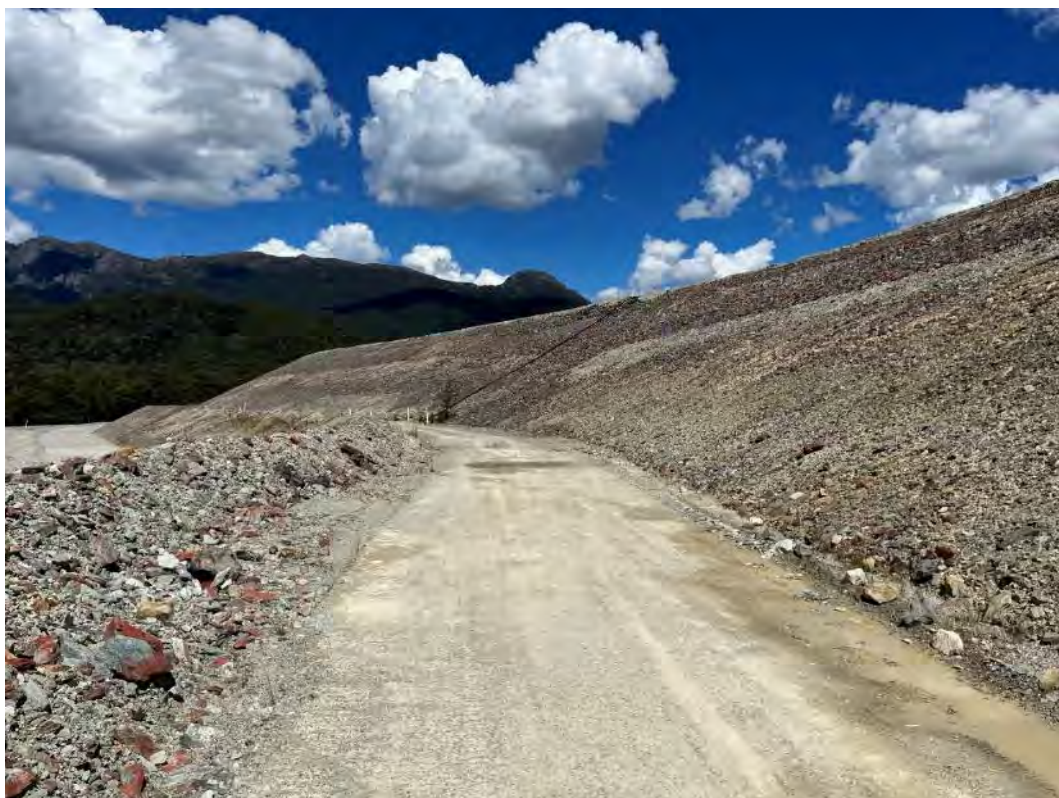
Photograph 22 – downstream slope of northern embankment looking east, good condition.

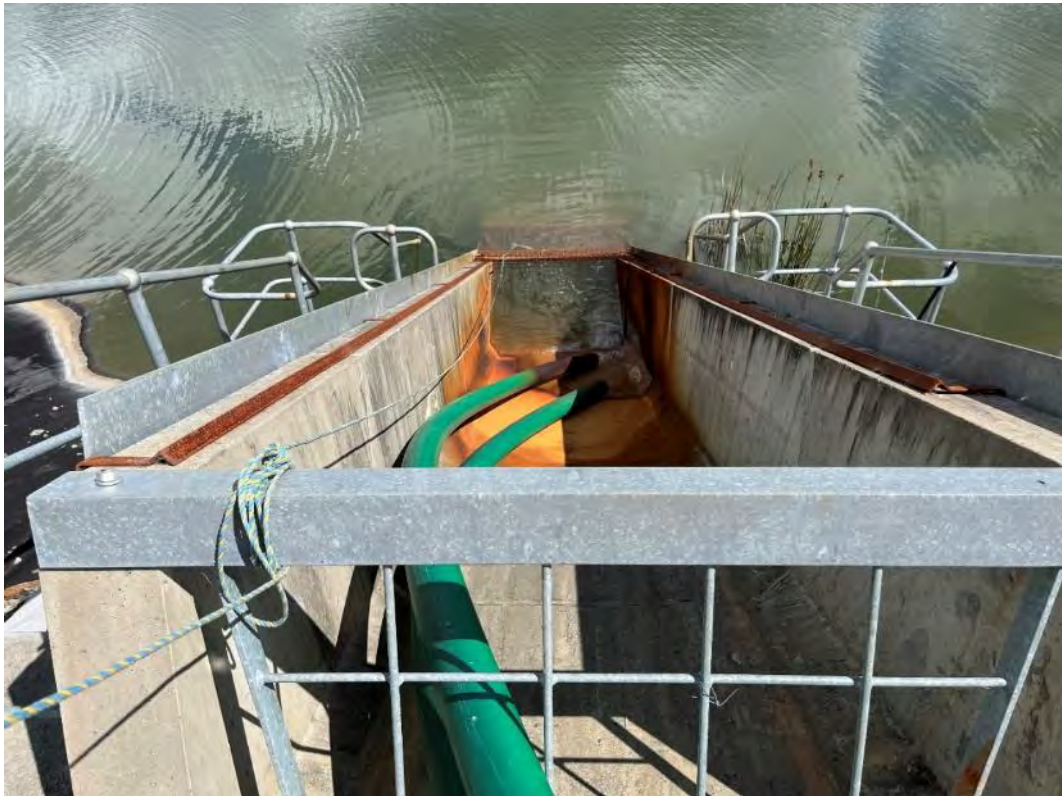
Photograph 25 – decant, clear of obstructions

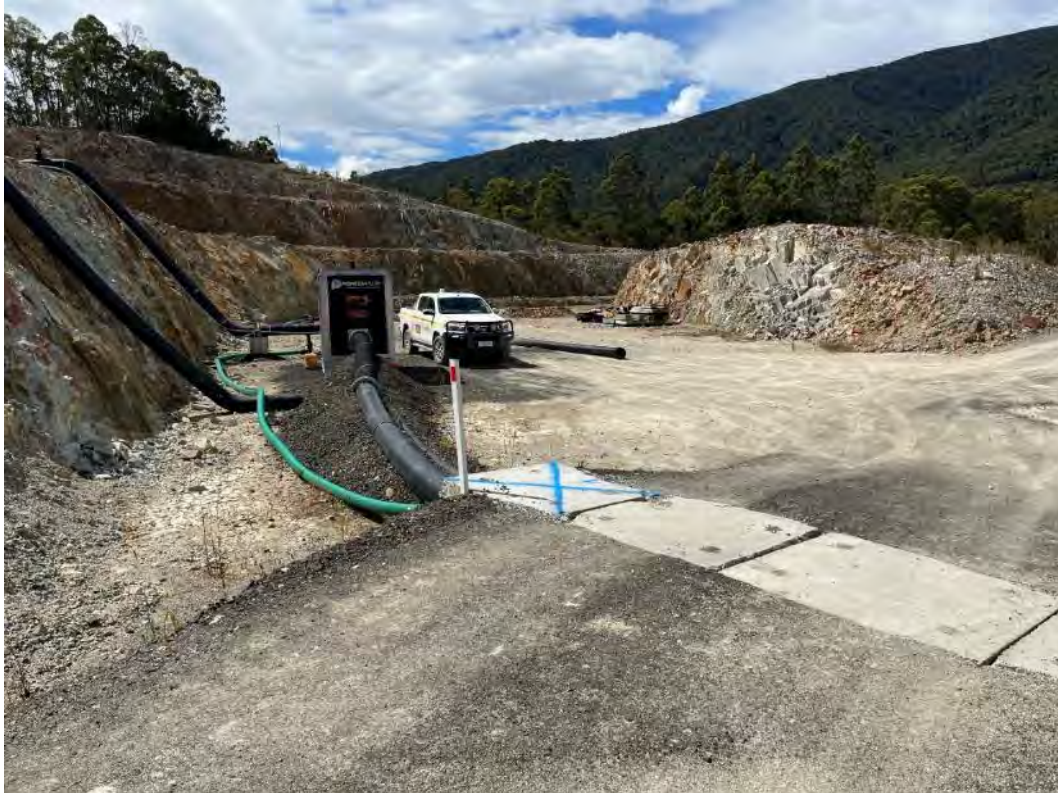
Photograph 27 – spillway, pump for sprinkler system will need to be removed as part of Stage 2 works

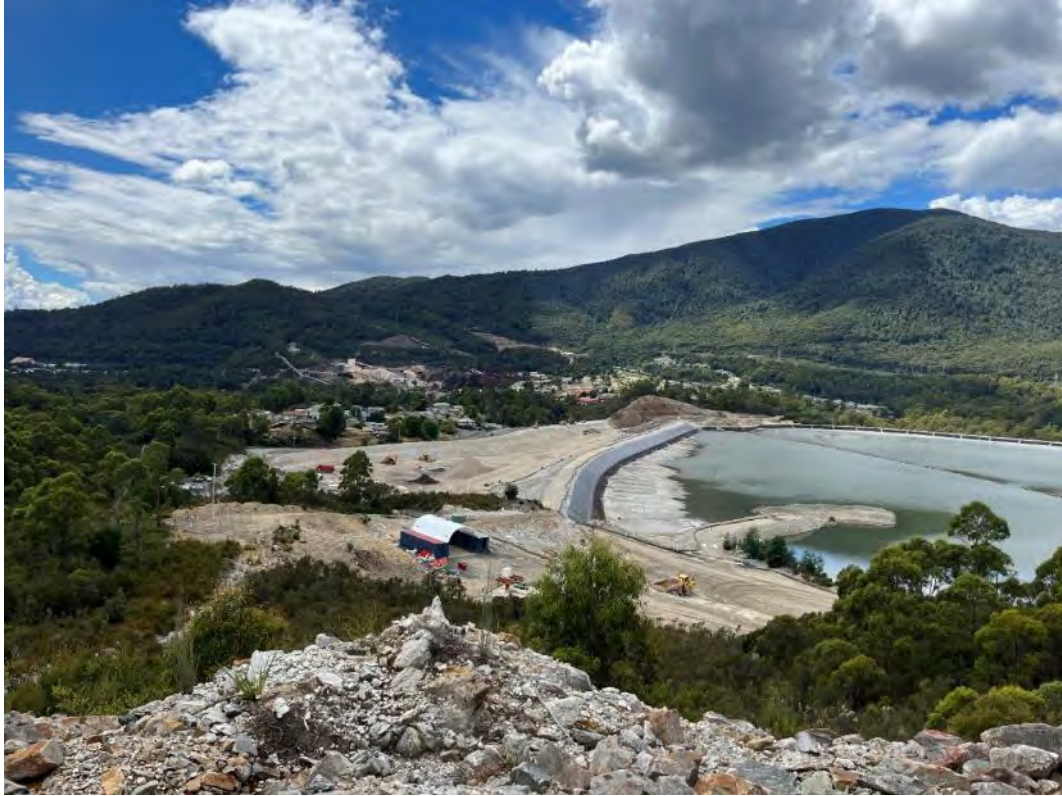
Photograph 29 – overview of western embankment, looking north from CWDD.

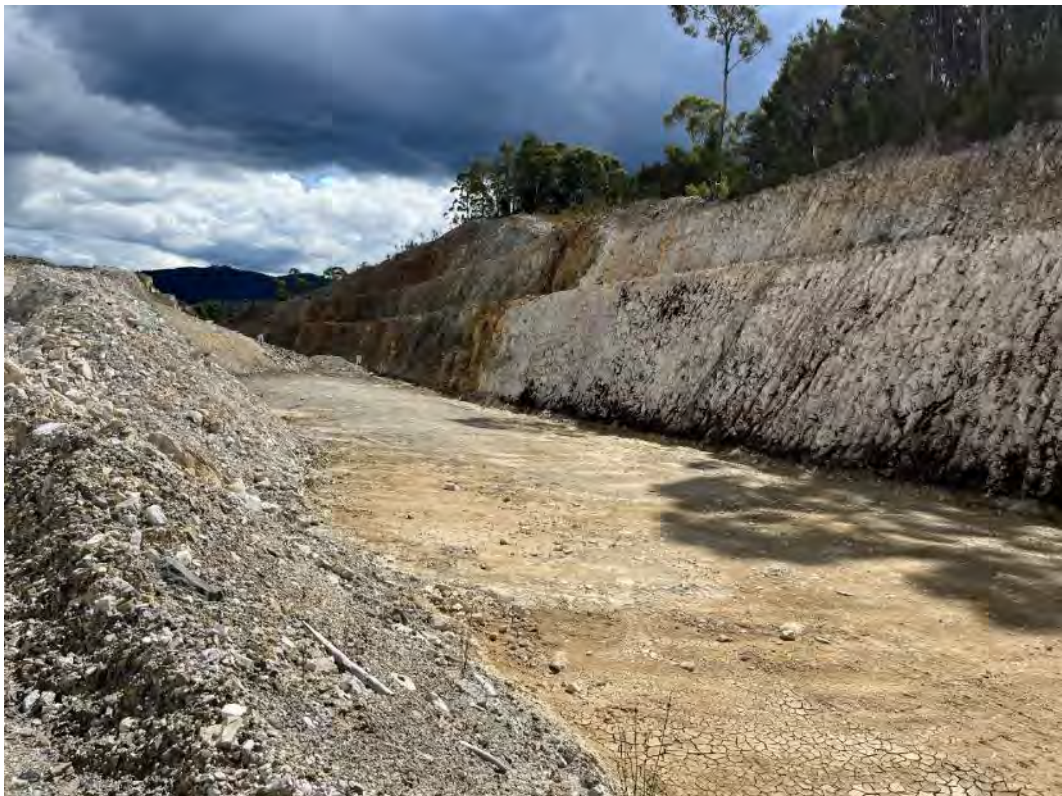
Photograph 30 – Diversion channel, looking south. Fill material placed to allow construction traffic to operate will need to be removed on completion of Stage 2 works.

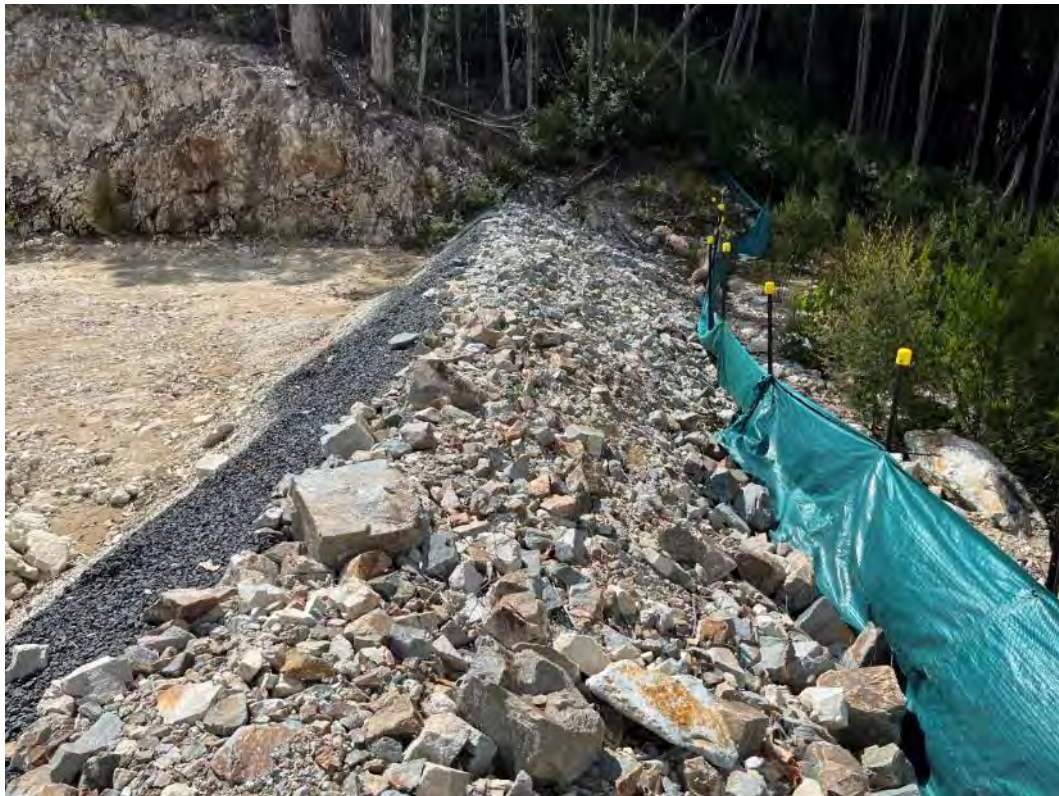
Photograph 31 – northern end of diversion channel. Note fill material placed for construction traffic will need to be removed once Stage 2 works are complete.

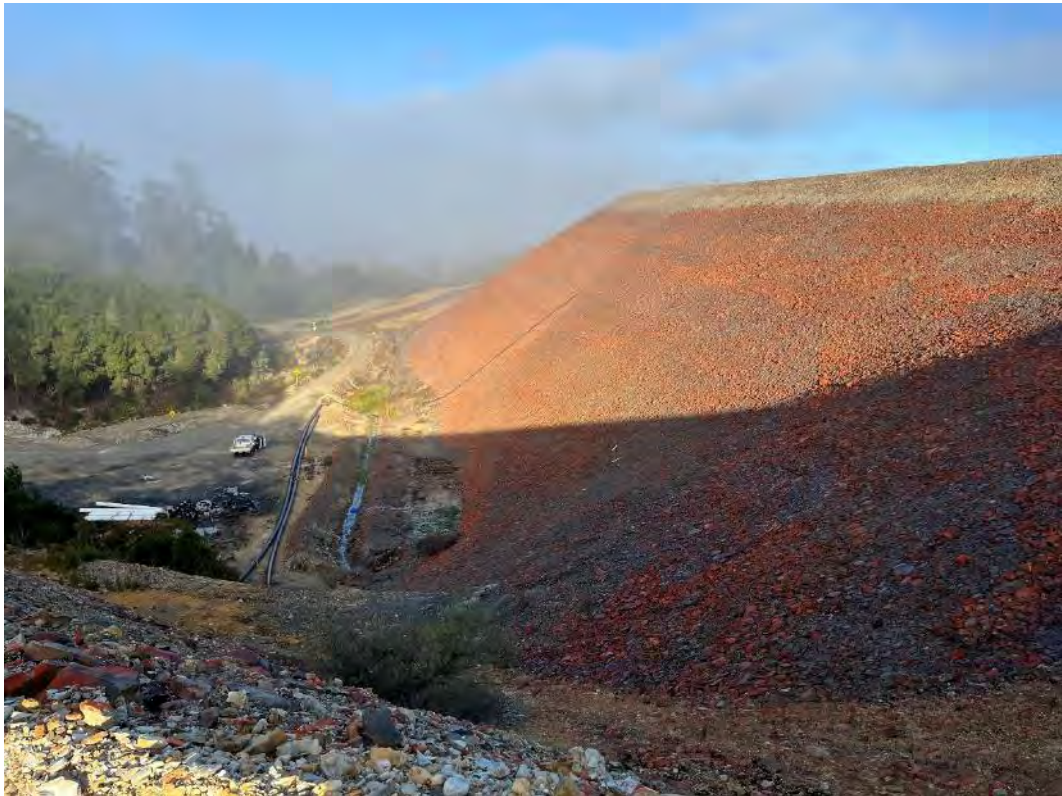
Photograph 3 – Downstream slope western buttress and dense vegetation in toe drain, looking north.

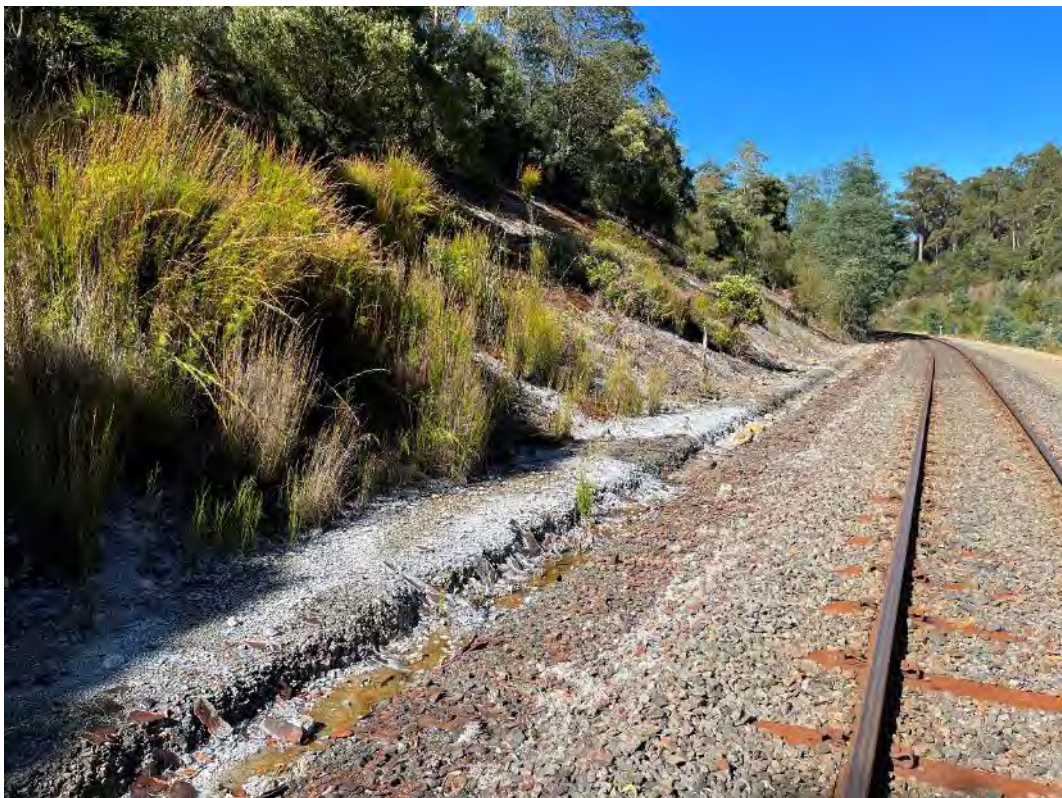
Item	Criteria	Checked	Comment	Photo Reference
	Slumps, bulging or erosion	Y	several points of localised very minor erosion associated with low points in the levee embankment bench at the top of the cutting	
	Stability of railway cutting	Y	Good condition	
	Vegetation growth on railway cutting	Y	Generally healthy vegetation comprising a mix of saplings and mature trees. Vegetation at the southern most end of the cutting has been slashed.	
	Seepage / soft spots	Y	Seepage and considerable salt precipitation evident towards the northern end of the cutting. Seepage and salt is below seep at top of slope.	6, 7
Other Comments	1. seepage and salt expression requires investigation.

Photograph 6 – salt on railway cutting batter

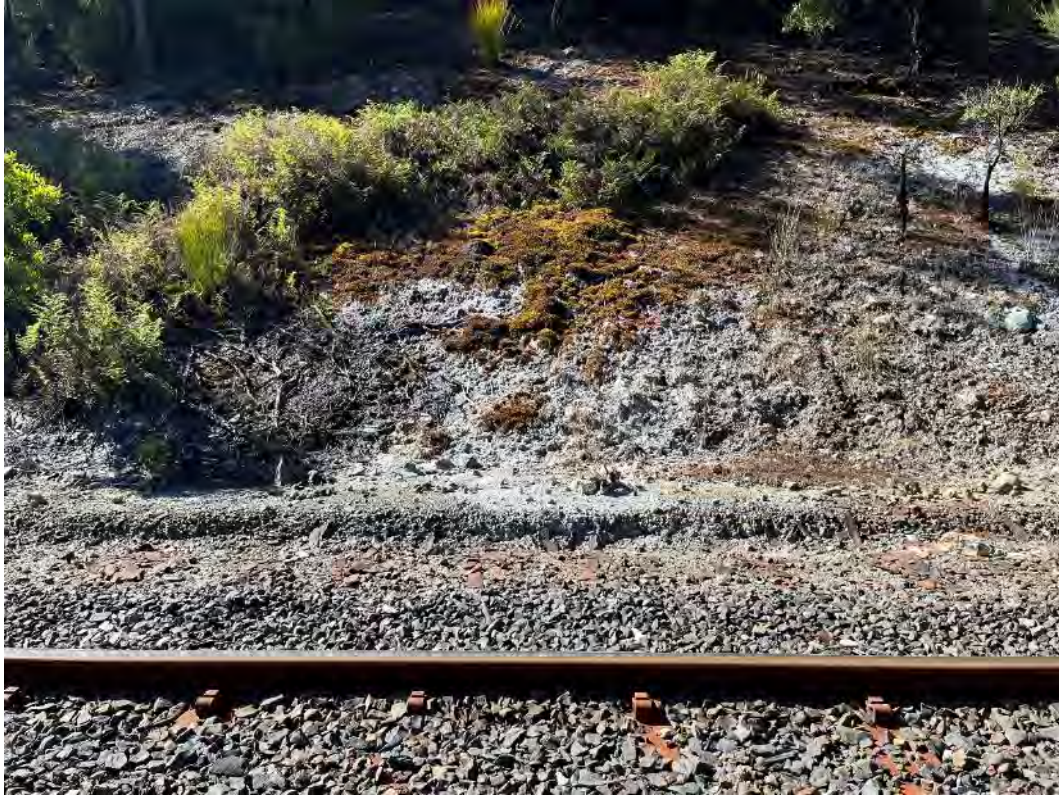
Photograph 7 -seepage and salt at toe of railway cutting

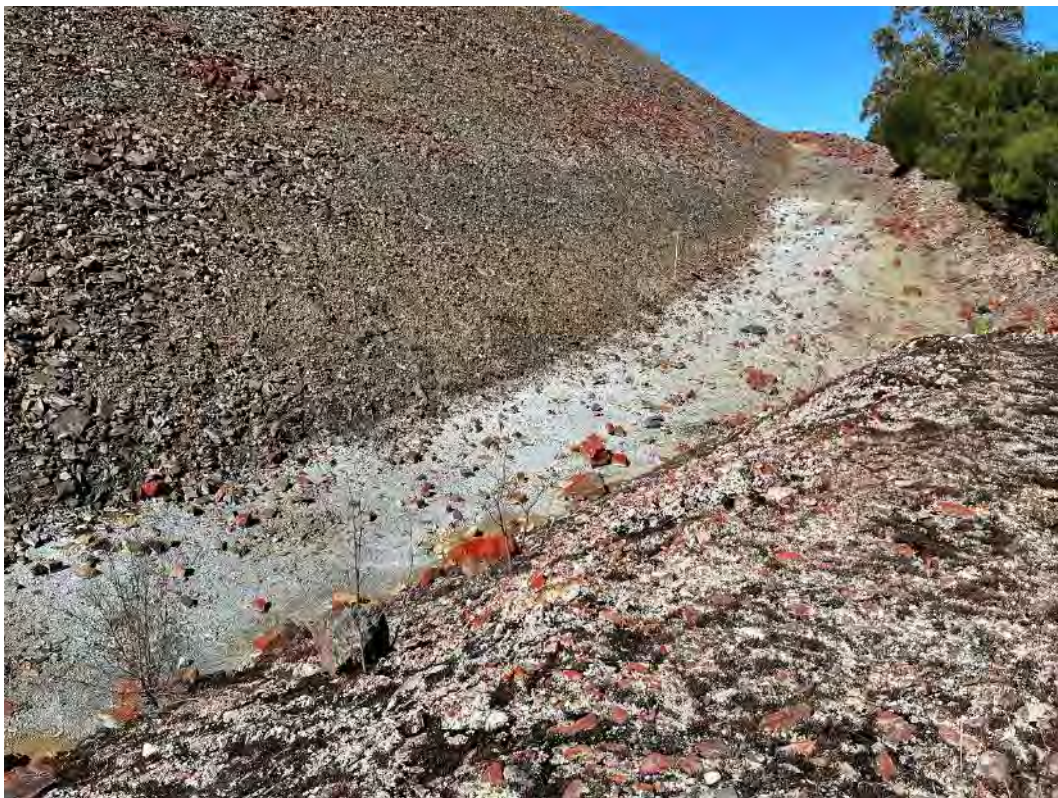
Photograph 10 – Downstream slope of northern embankment, looking west towards Levee Embankment, note salt precipitation.

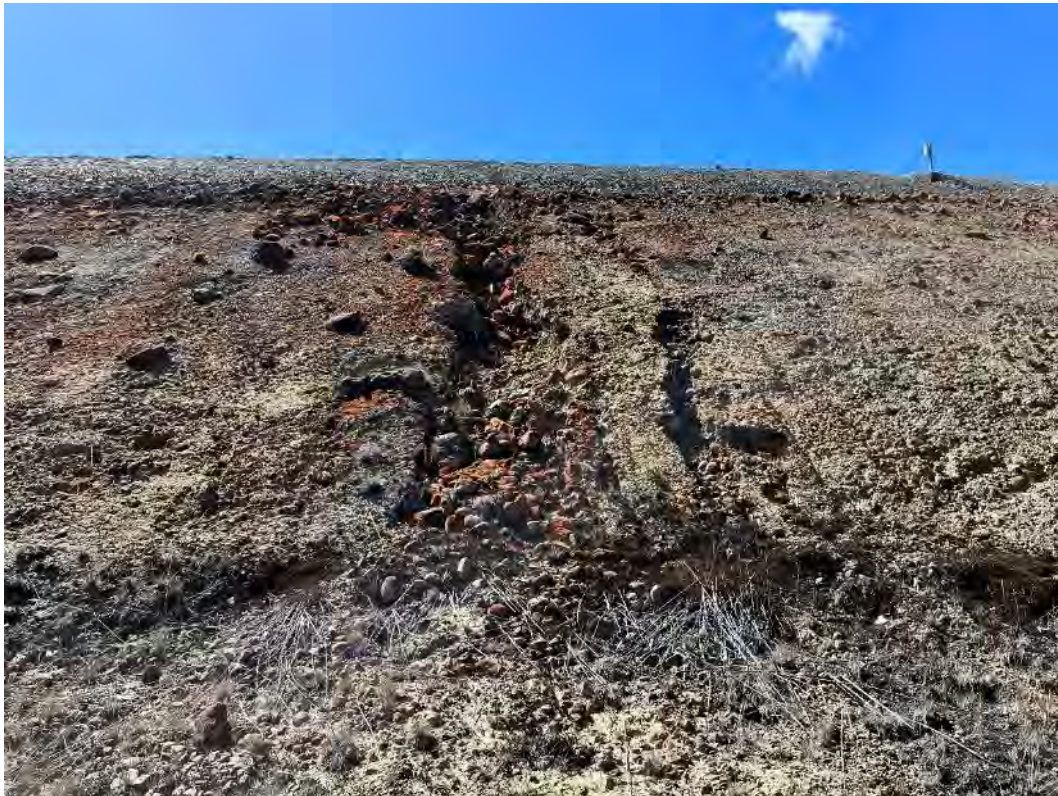
Photograph 13 – Erosion below Levee bench (typical).

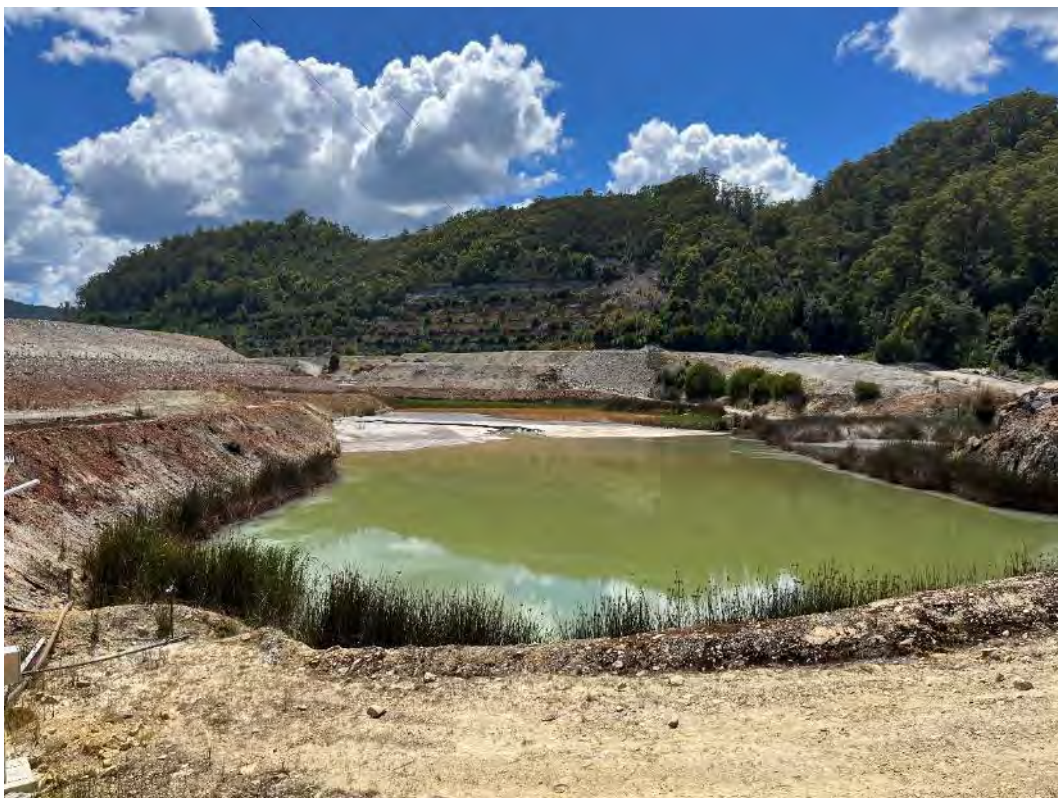
Photograph 29 – reeds on downstream batter of Levee embankment signify the upper extent of broad wet area.

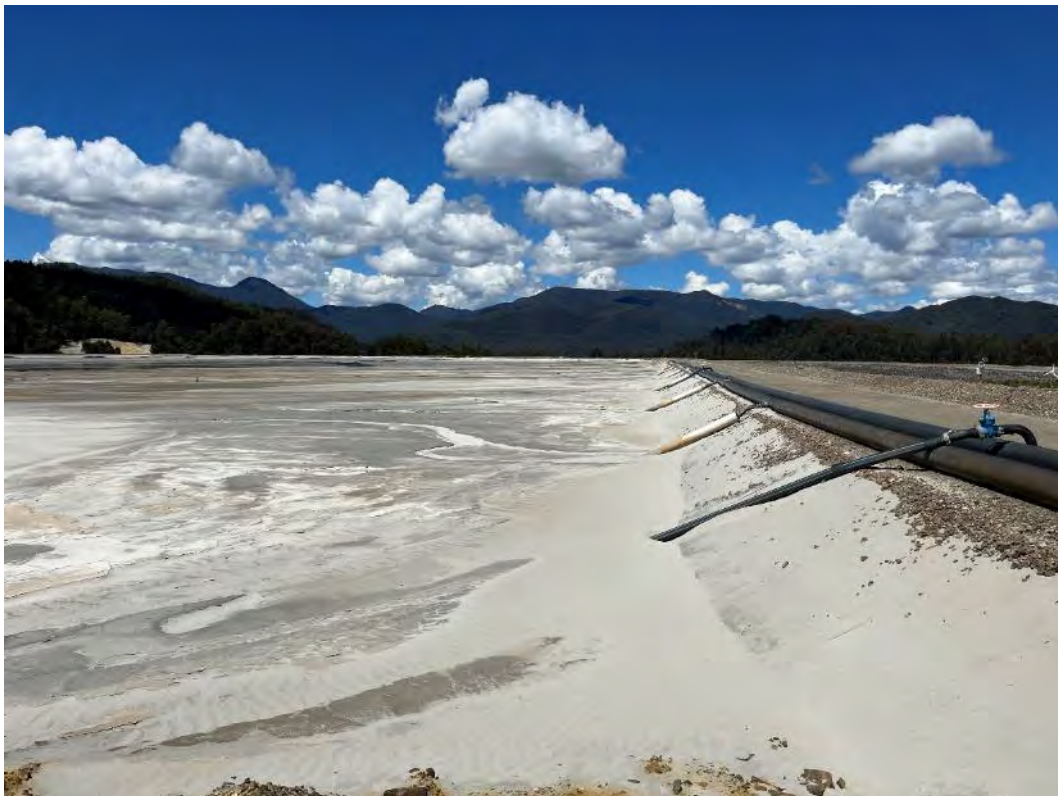
Photograph 31 –western buttress overview, note wind blown tailings.

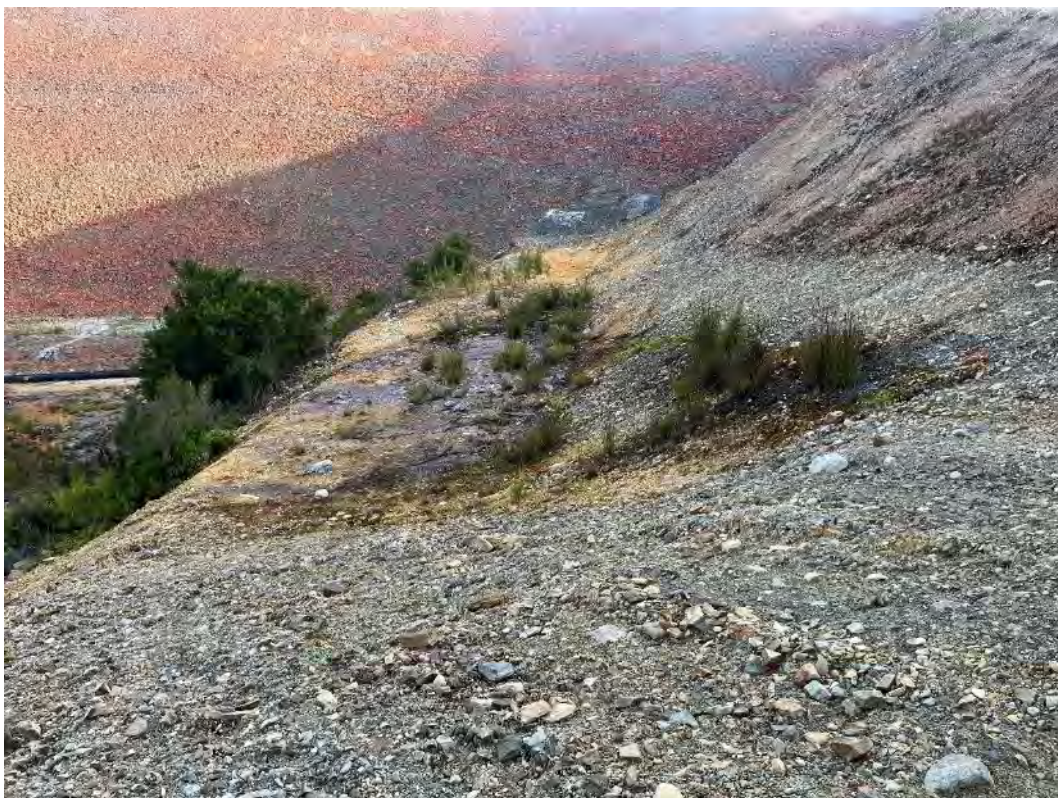
Photograph 33 – seepage from downstream toe of Southern embankment.

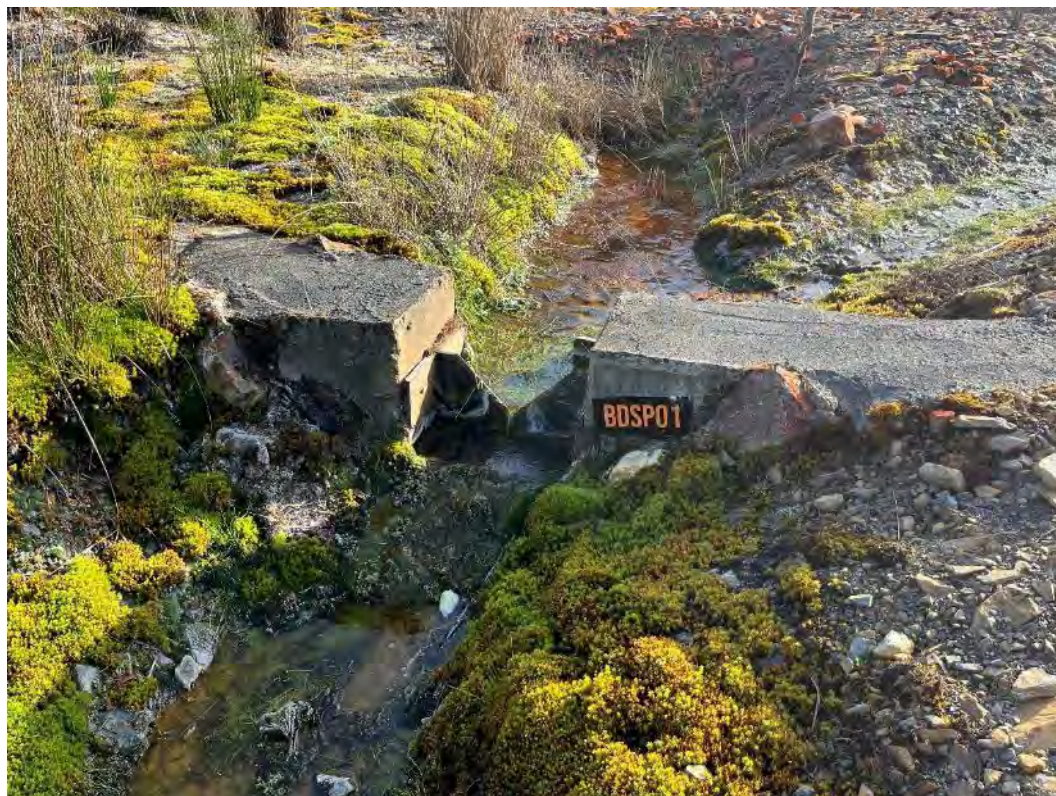
Photograph 34 – Seepage at southern access ramp, looking north.

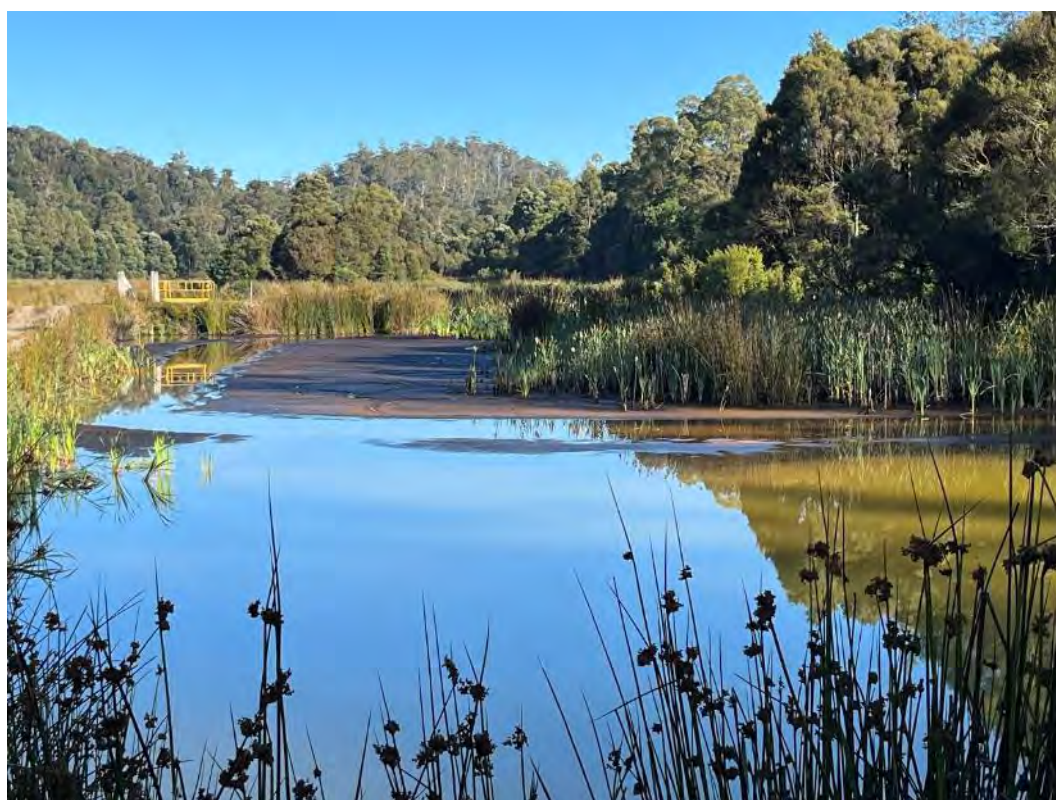
Photograph 39 – Polishing Pond Cell 1. Large amounts of sludge have accumulated within several cells.

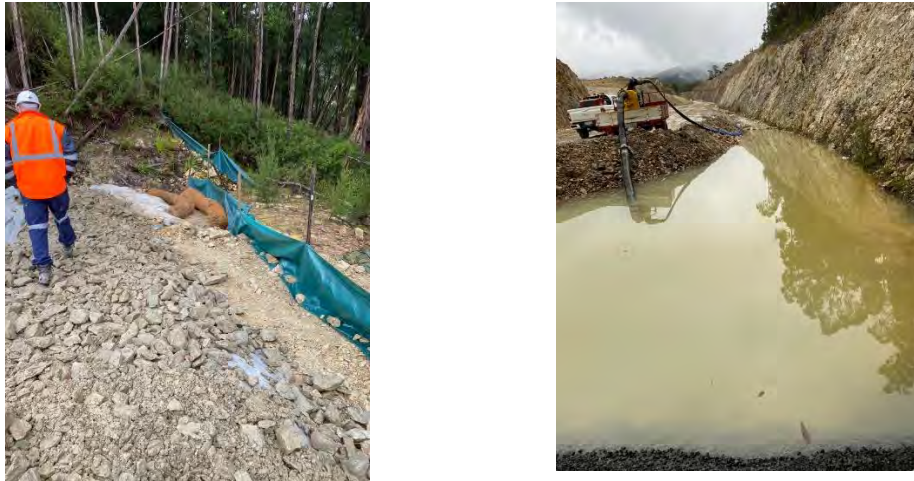
On 7 July 2022, MMG Rosebery notified the EPA via email regarding the discharge of turbid water from the emergency spillway and northern wall of the 2/5 Dam TSF embankment into the Stitt River. The event was caused by 37 mm of rain falling in the previous two days mobilising sediment from construction areas around the 2/5 Dam TSF (Figure 2-1). The company reported that the runoff was observed late in the afternoon with additional controls to reduce sediment runoff implemented the next morning. Management measures included the construction of additional silt fences and 'eco logs', and the positioning of pumps that can be used to transfer turbid water back to the TSF if required (Figure 2-2). The company also implemented a sediment control review at the site and conducted an audit of contractors HSE policies.

Figure 2-2. Implementation of improved sediment retention infrastructure following discharge of turbid water to the Stitt River (left), and use of pumps to transfer turbid water to the TSF (right).
