# PROGRESSIVE REHABILITATION AND CLOSURE PLAN

## DUGALD RIVER MINE

MINERALS AND METALS GROUP PTY LTD

PREPARED BY: WULGURU TECHNICAL SERVICES

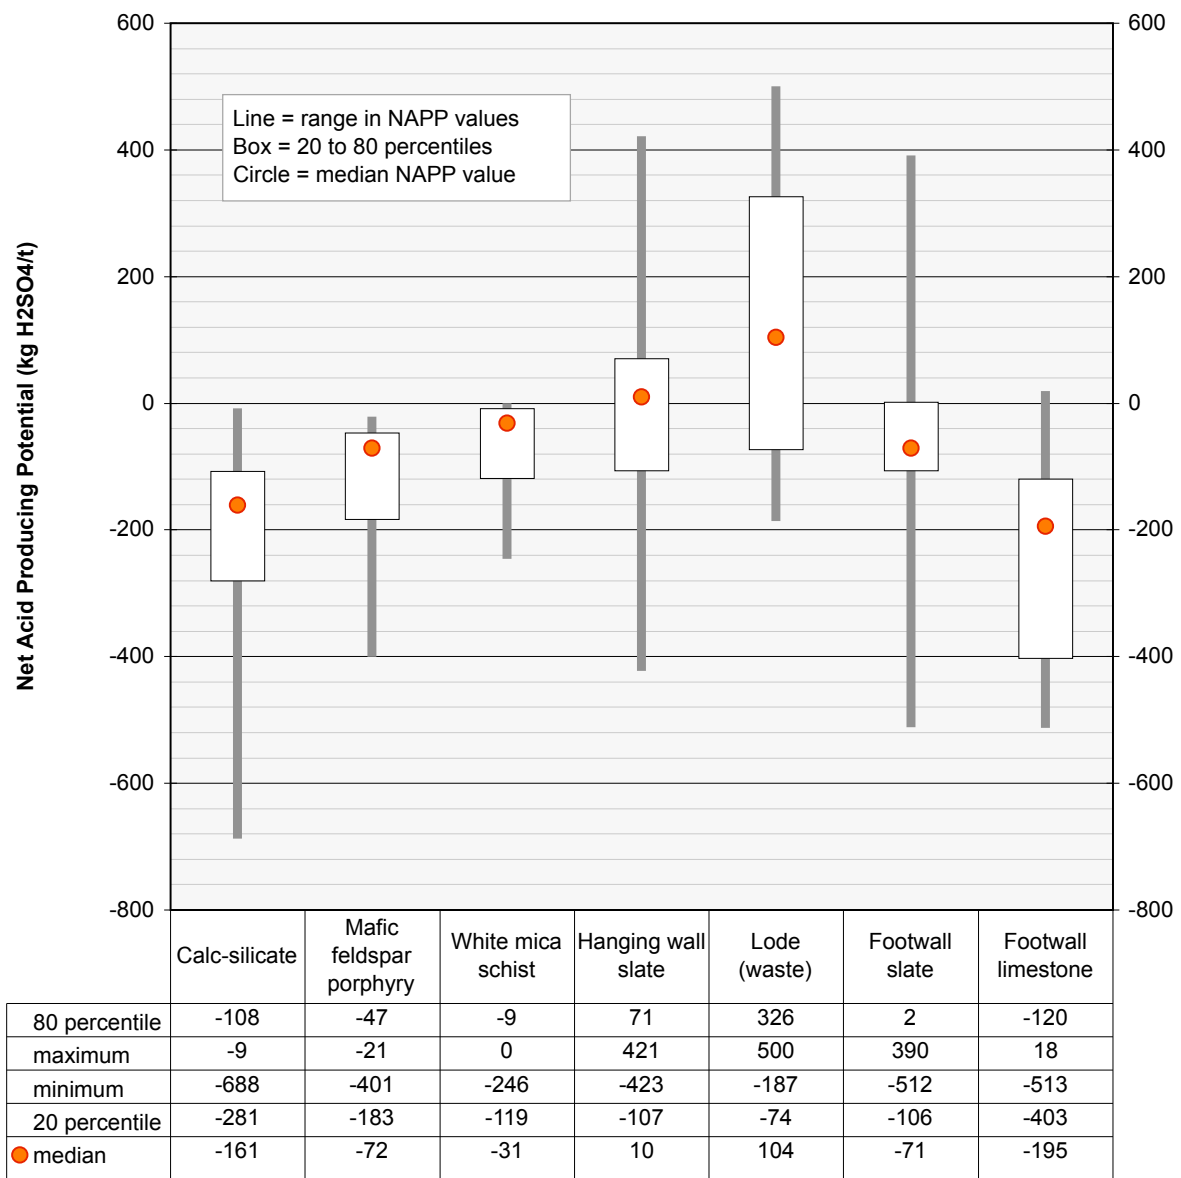
**FIGURE 4: Statistical summary of NAPP data for Dugald River waste rock**  
(compilation of results from all geochemical studies)

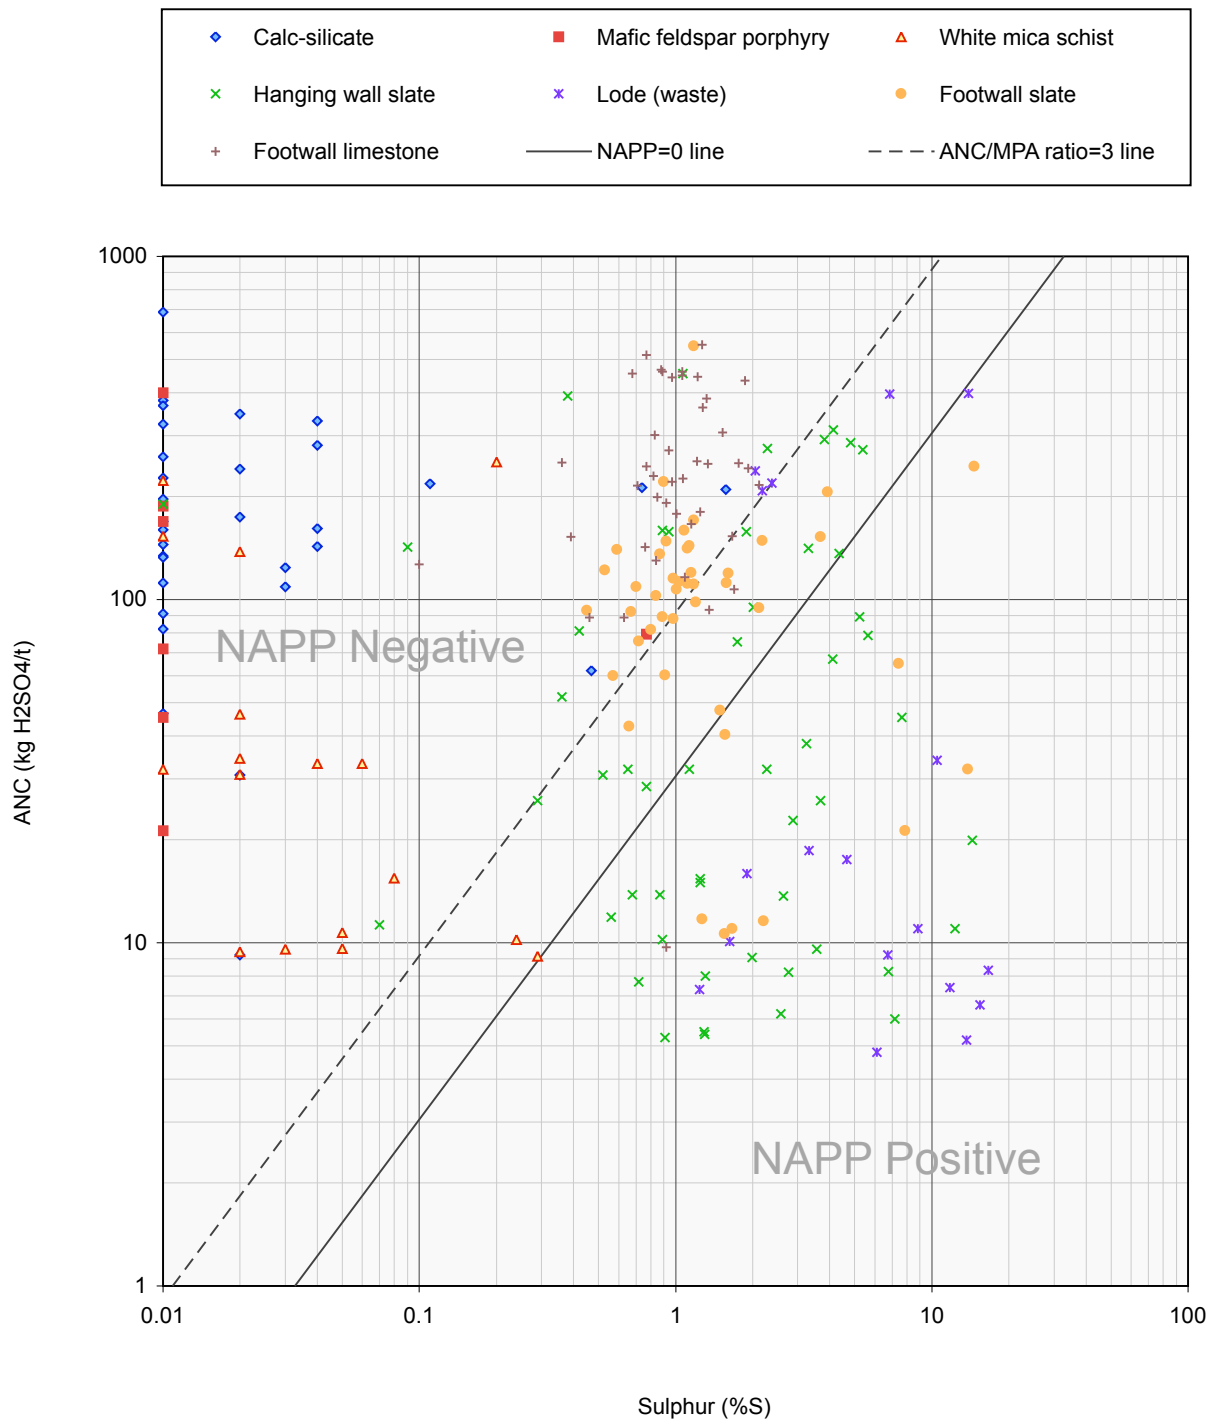
**FIGURE 5: Acid-base account plot for Dugald River waste rock**  
 (compilation of results from all geochemical studies)

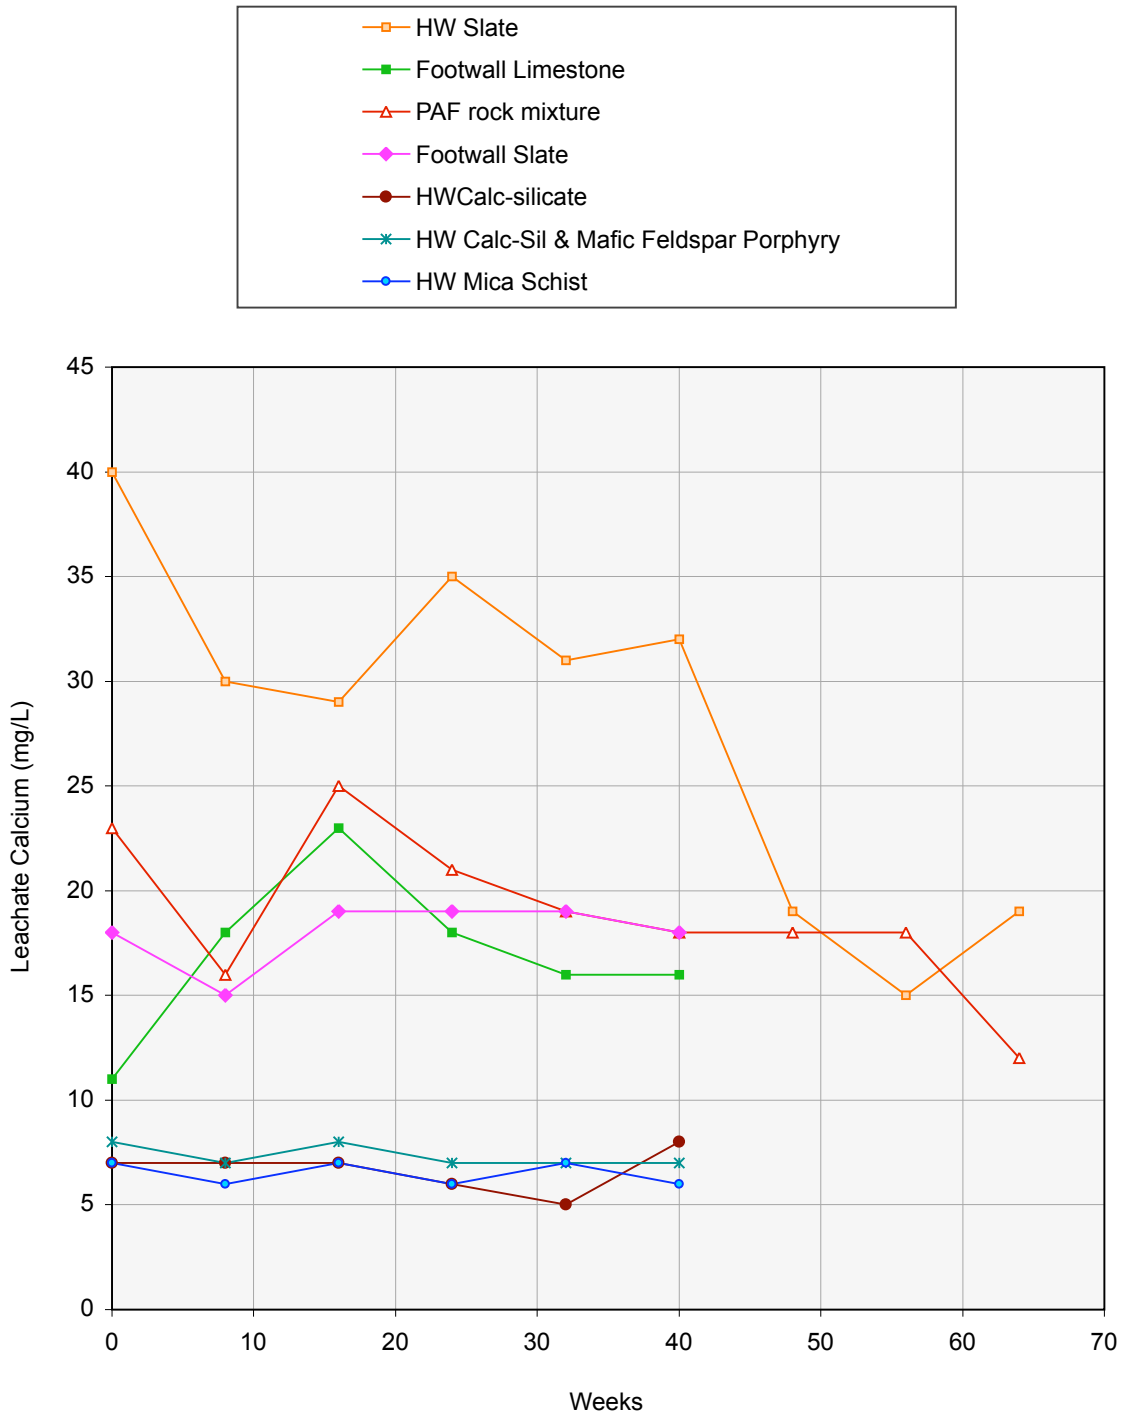
**FIGURE 14: Plot of calcium concentrations in leachates from AARC column leach tests on Dugald River waste rock**

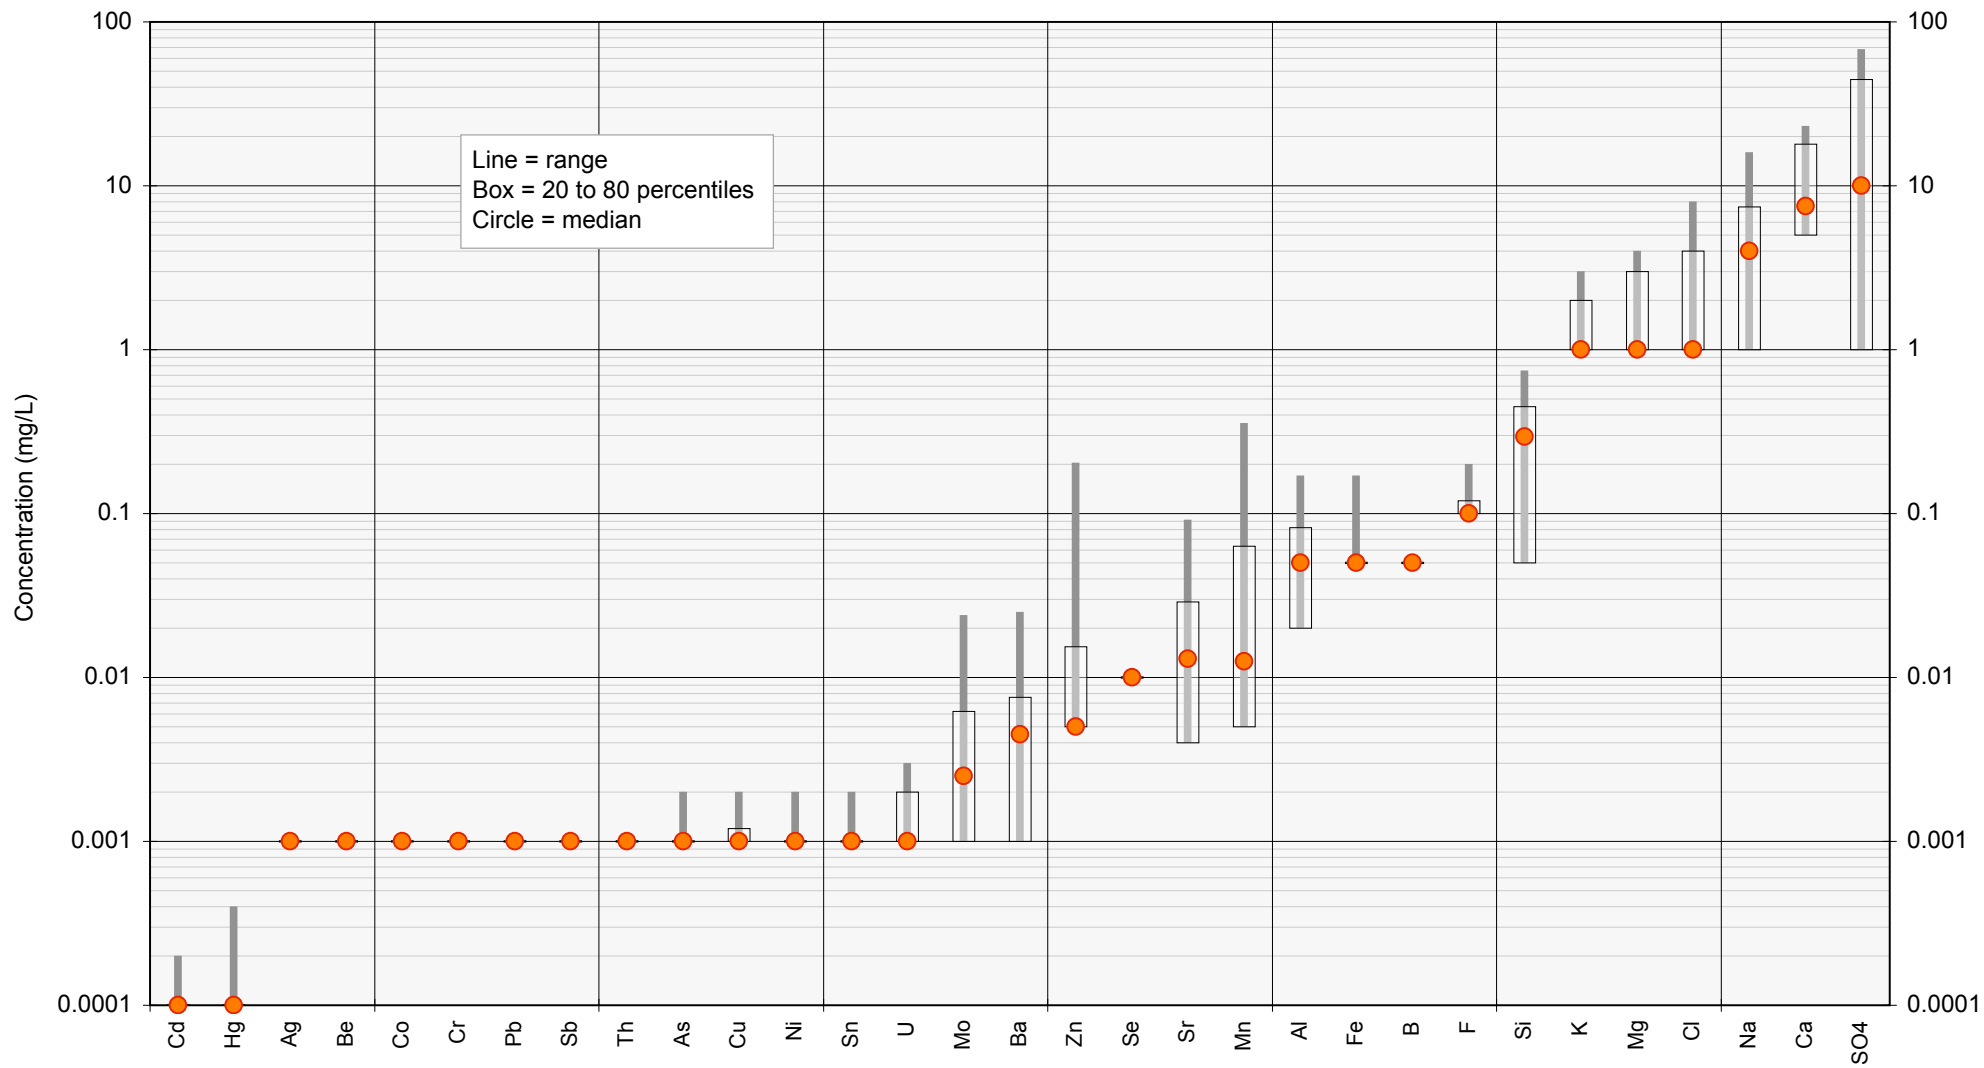
FIGURE 15: Statistical summary of AARC column leach assay data for samples comprising NAF Dugald River waste rock

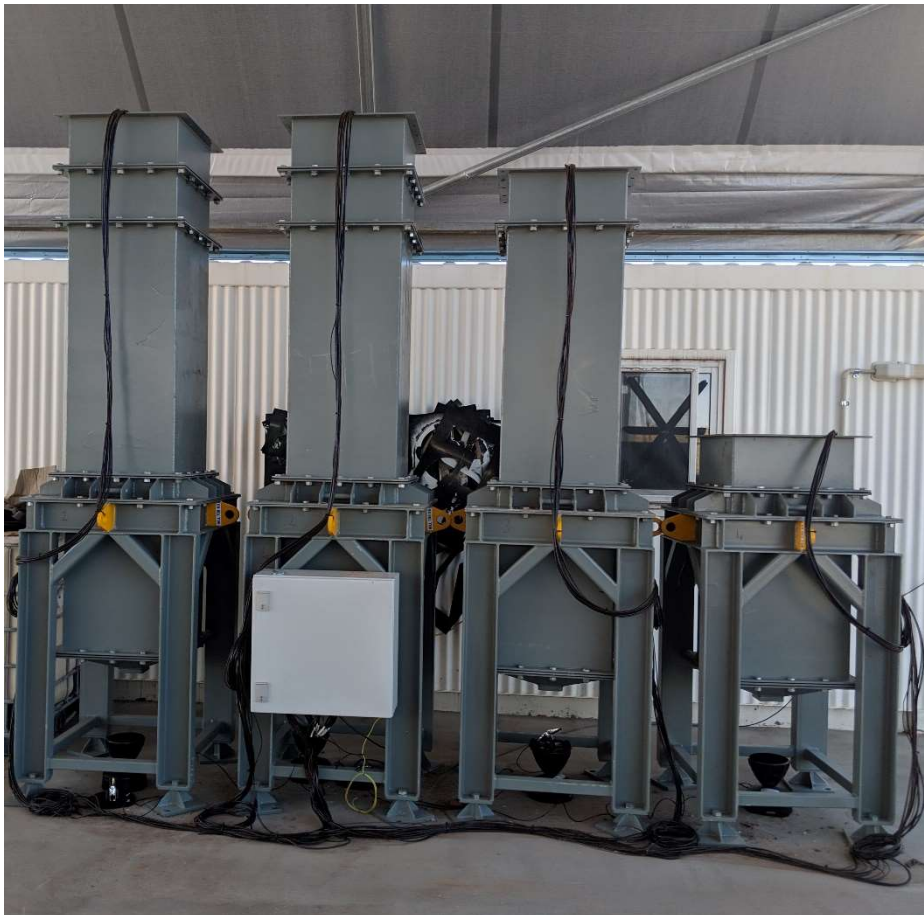
**Photograph 1 Cover column trial**

Four columns, one for each cover option, were built to specifications provided by SGME. A built column is shown in Photograph 1. Columns ranged from 1.1 m to 2.5 m tall depending on the thickness of the cover trialled. Each column has a surface area of 0.25 metres squared (m<sup>2</sup>).

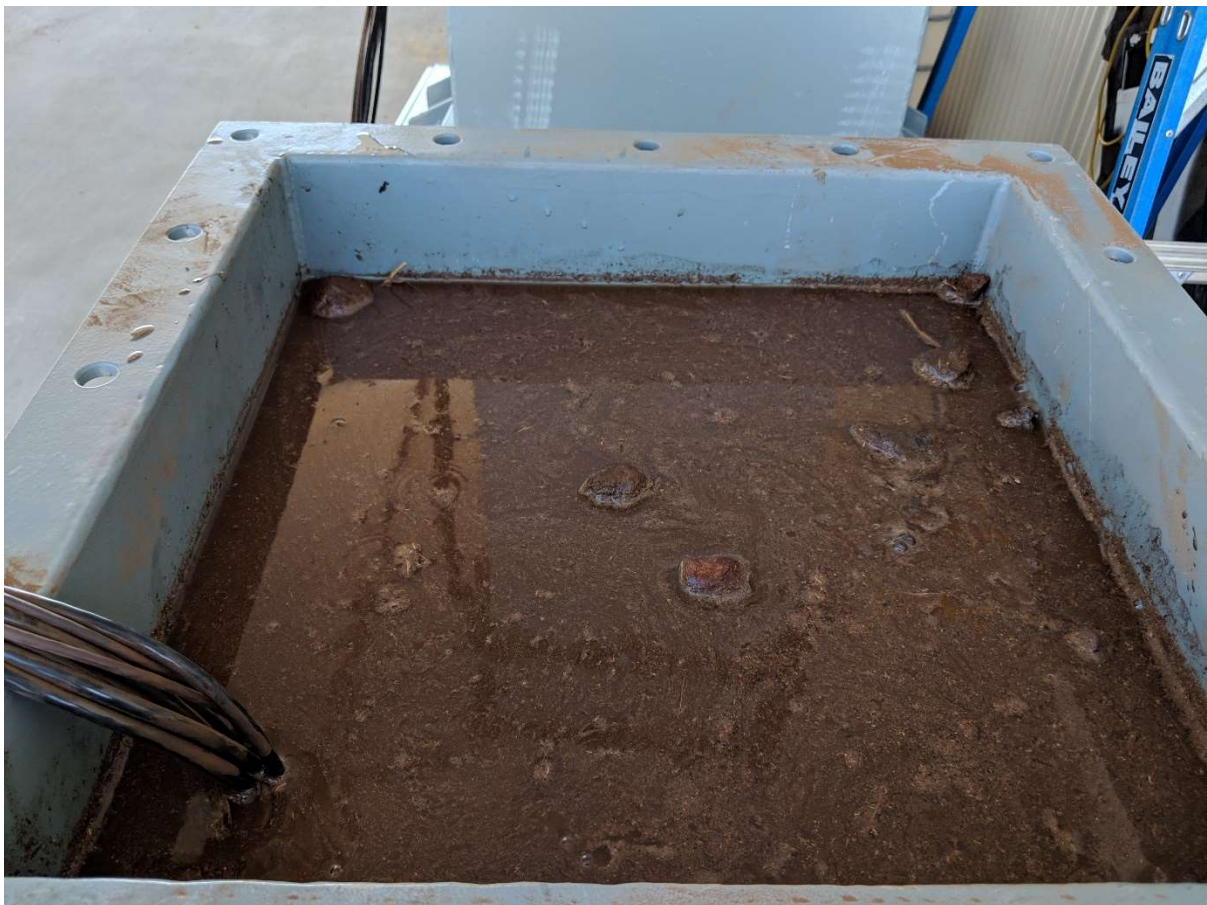
**Photograph 2 Ponding of water on the trials**

During wetting events, artificial rainfall could pond on the surface of the trials (Photograph 2).

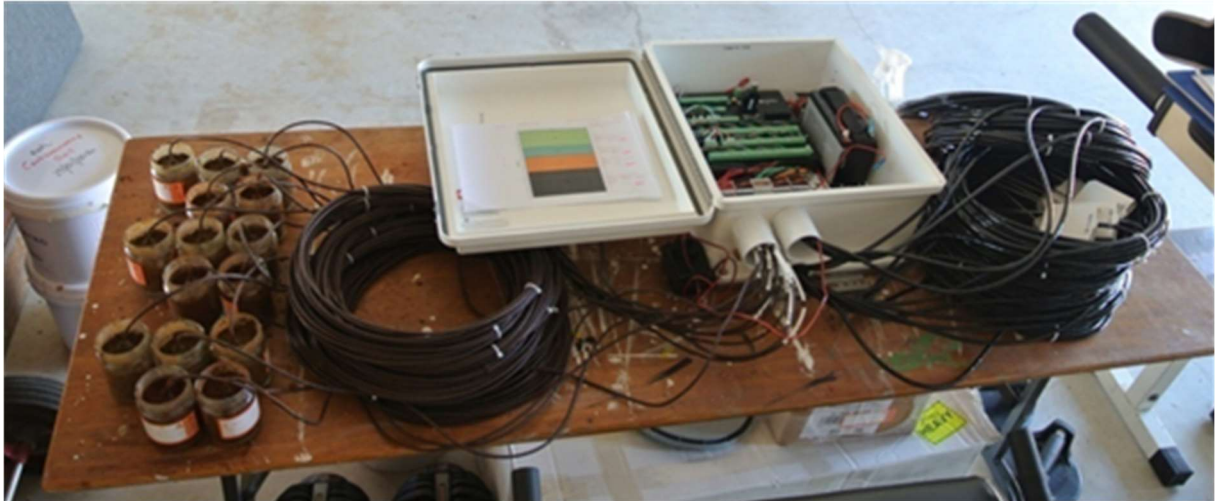
Photograph 3 Matrix suction sensor calibration

Photograph 3 illustrates the experiment set up for calibration. Matric suction sensors are embedded at the expected field density and wired to the data logger ready for measuring the  $\Delta T$ .

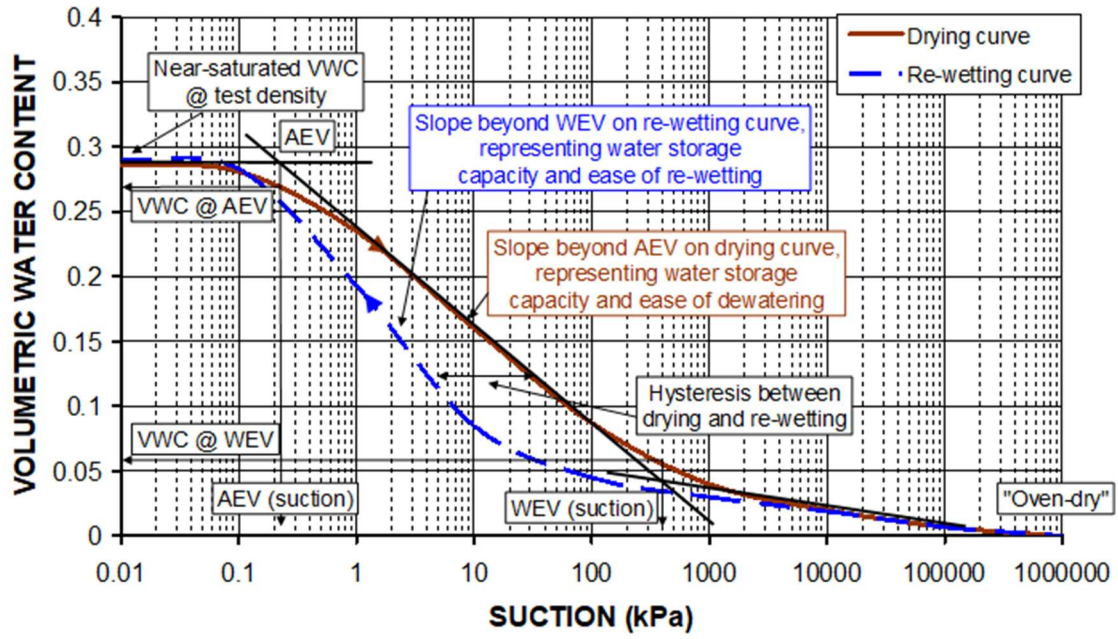
Over the suction range up to about 1,000 kPa, matric (or capillary) suctions dominate, while above about 1,000 kPa the increasing concentration of salts in the pore water mean that osmotic (or solute) suctions come to dominate. Most soil-like materials exist at a suction of  $< 10,000$  kPa, and hence matric suction usually dominates. An exception is salt pan deposits and hypersaline tailings.

Figure 24 Key elements of the SWCC
