Annual Monitoring Review and Management Report 2022-2023

MMG Rosebery

Date: 30/09/2023

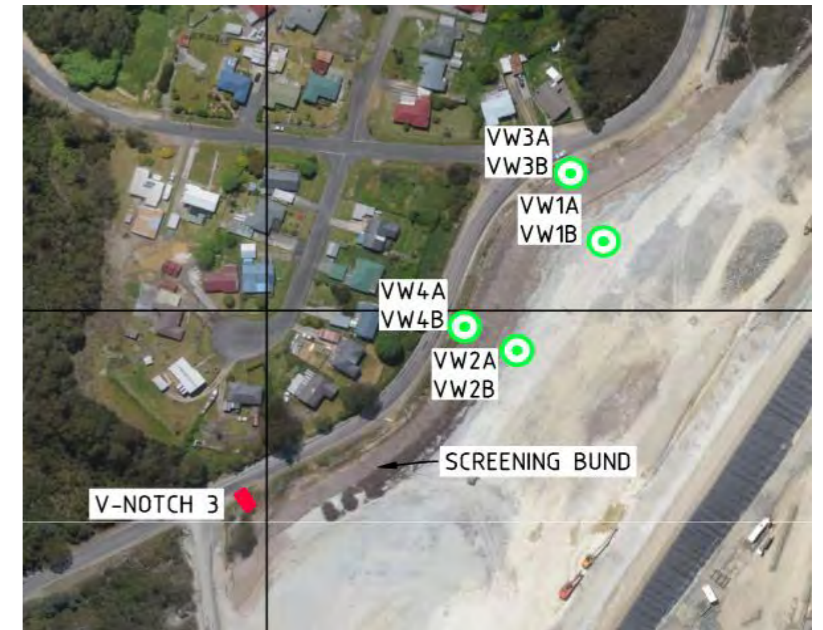
FIGURE 12

Piezometers were installed either side of the screening bund in May 2019, and 3 new piezometers have been installed in September 2022 to monitor construction works associated with the screening bund. The piezometers upstream of the screening bund reported a decrease of approximately 1 m before increasing again in November 2022 and appearing to stabilise. From September 2020 the pore pressures appear to stabilise independent of the pond elevation. **Figure 12** summarises the pore pressures since installation.

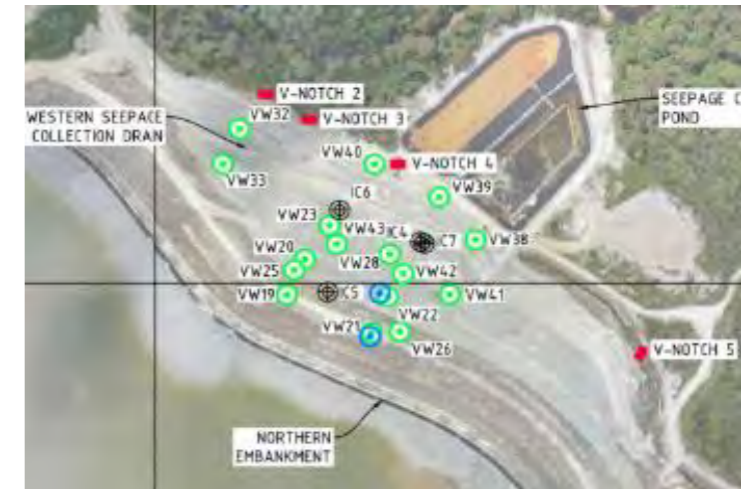
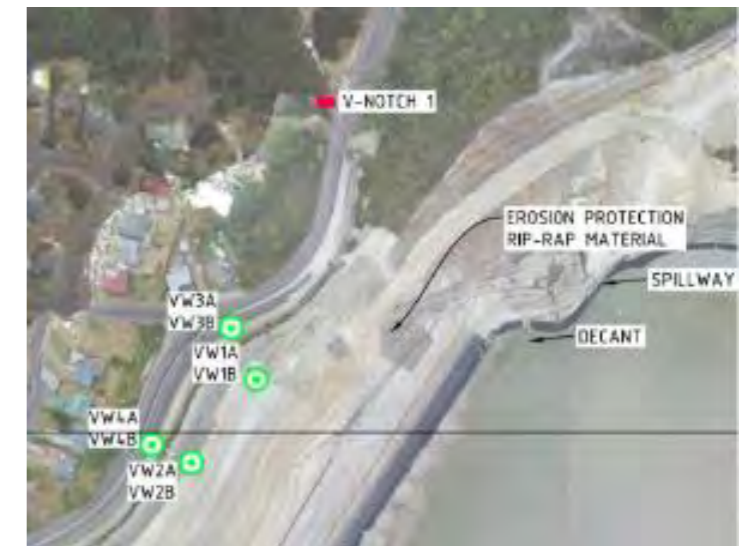
FIGURE 13

Monitoring of the V-notch weirs has been carried out on a monthly basis up to May 2022 and on a weekly basis from June 2022 by the ATCW 25 Dam site engineer. A summary of monitoring results since January 2018, or installation is provided in **Figure 13**.

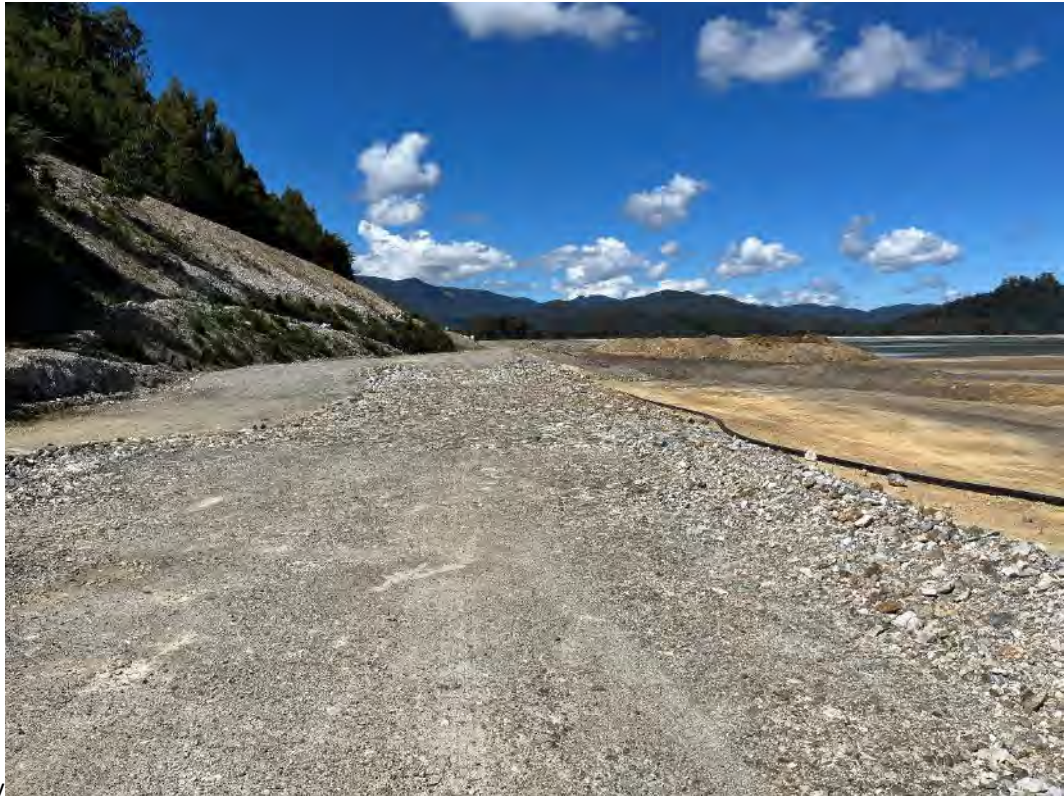
Photograph 24 – Typical slump on the upstream face due to rainfall and spigot conductor pipe spills
